ARCHAEOLOGICAL
SERVICES
DURHAM UNIVERSITY

Walkmill Woods and Colliery
Moresby
Cumbria

archaeological assessment

report 5879
December 2022

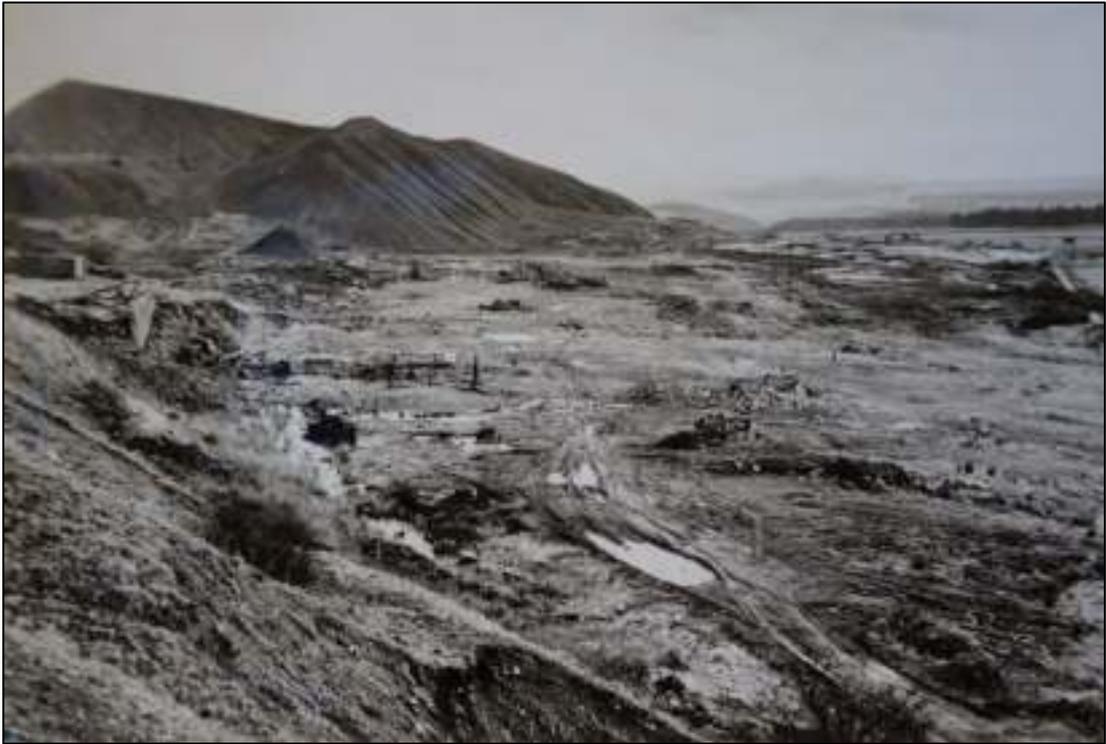
Photograph 1: A view looking south across the demolished colliery site, with the pit heap in the background. The shafts and heapstead were on the level ground at the middle of the view. Three tall poles, upper right, mark the approximate position of the coke ovens. Similar photos, now held by Cumbria Archives in Carlisle, show the scale of the pit heap after closure

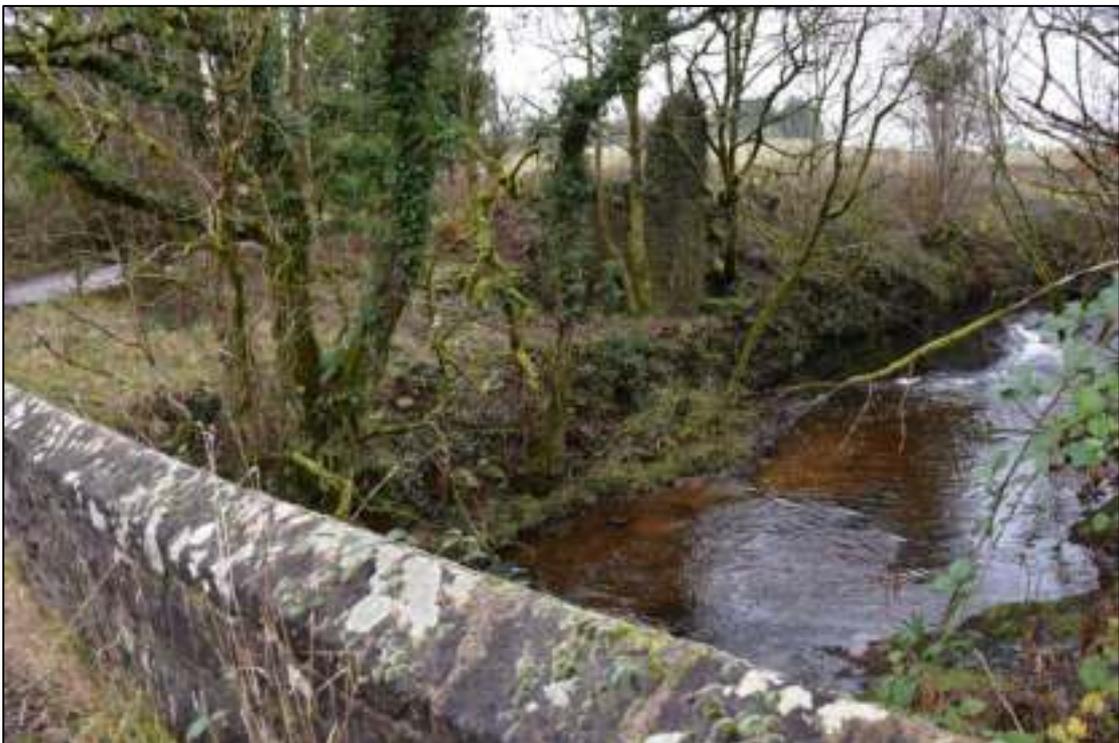
Photograph 2: The River Keekle and the ruins of the Walk Mill, seen from Walkmill Bridge

- 5.2 **Walkmill Bridge** and the **Walk Mill** are just south-east of the study area and the bridge is still in use. The south gable of the ruined mill stands on a rocky outcrop just east of the road (Photographs 2, 3). A little to the east is an old **packhorse bridge** leading to a quarry and early coal shaft on the south side of the river (Photographs 4, 5).

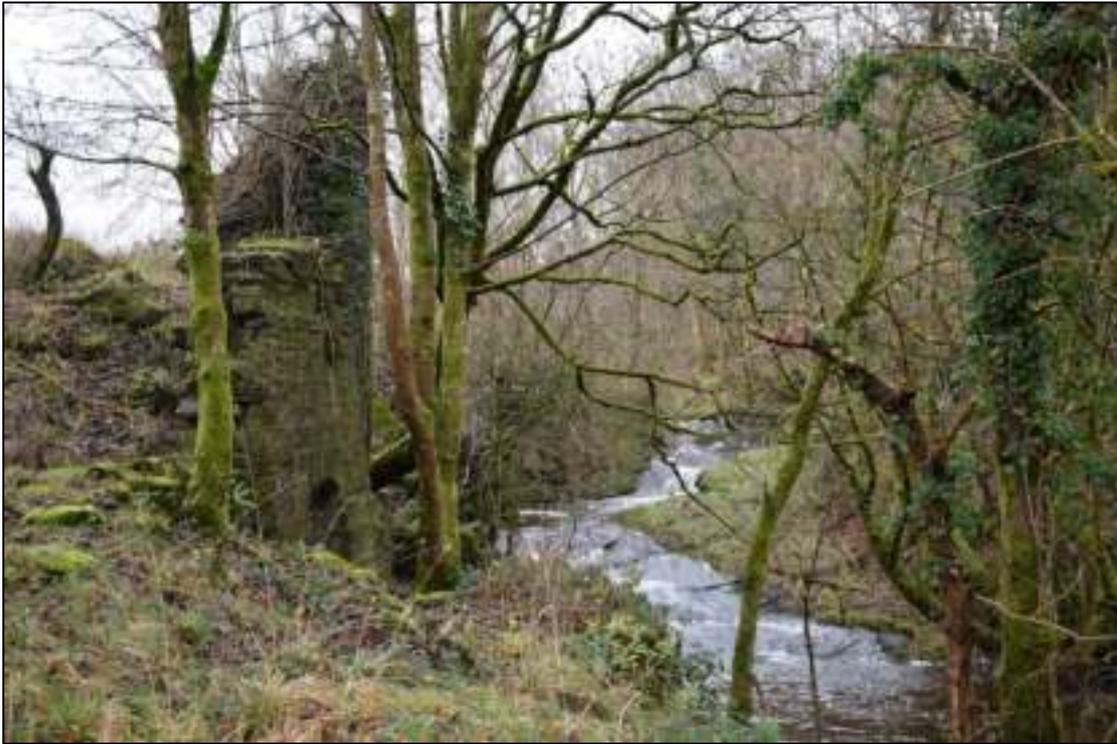
Photograph 3: The south face of the old mill building, with an arched opening low in the face

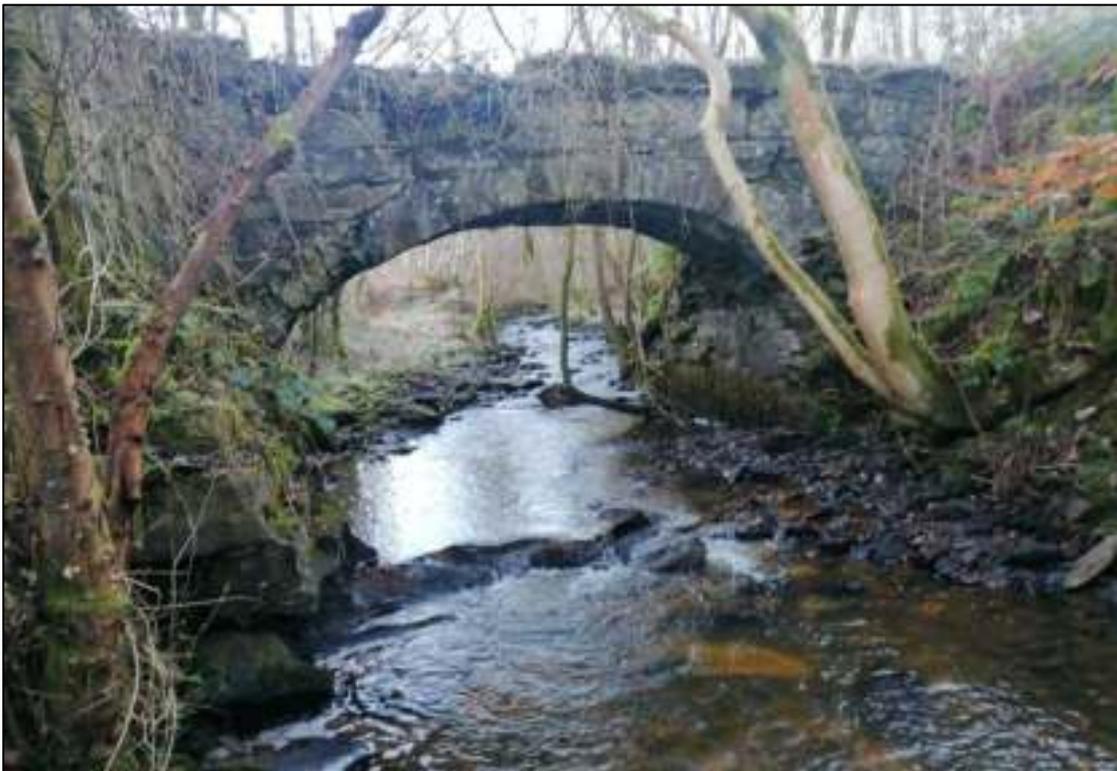
Photograph 4: The old packhorse bridge upstream from the Walk Mill. Photo by Brian Mossop

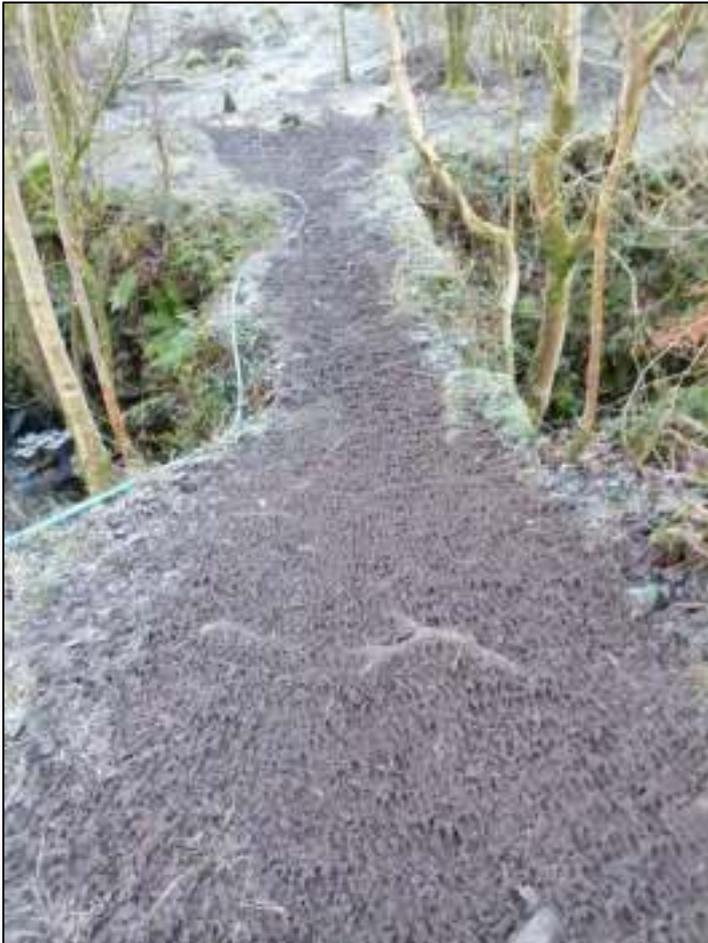
Photograph 5 (left): A view looking across the narrow packhorse bridge. Photo by Brian Mossop

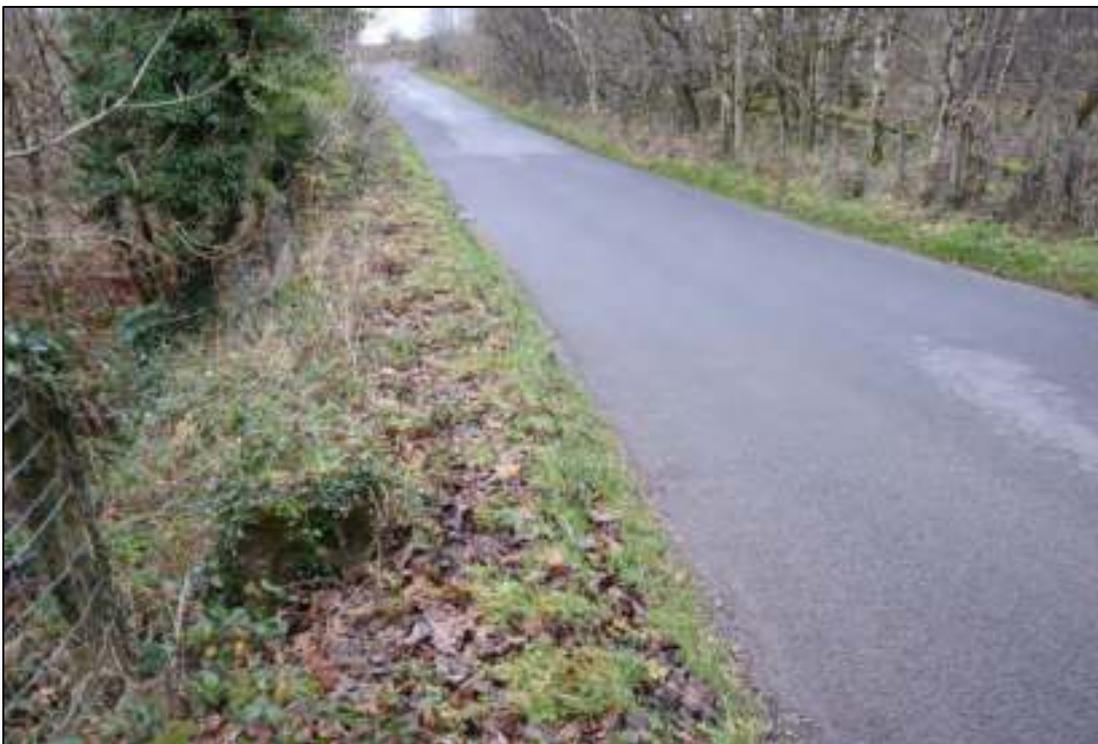
Photograph 6 (below): The old milestone on the roadside verge south of the colliery site. A view looking west towards the car park

- 5.3 An old **milestone** lies on the south side on the road immediately south of the site (Photographs 6, 7). The red sandstone block is in a fair condition but the iron plates that carried its inscription have been removed. Nineteenth-century OS maps show that the east face once read 'Whitehaven 3 miles'.

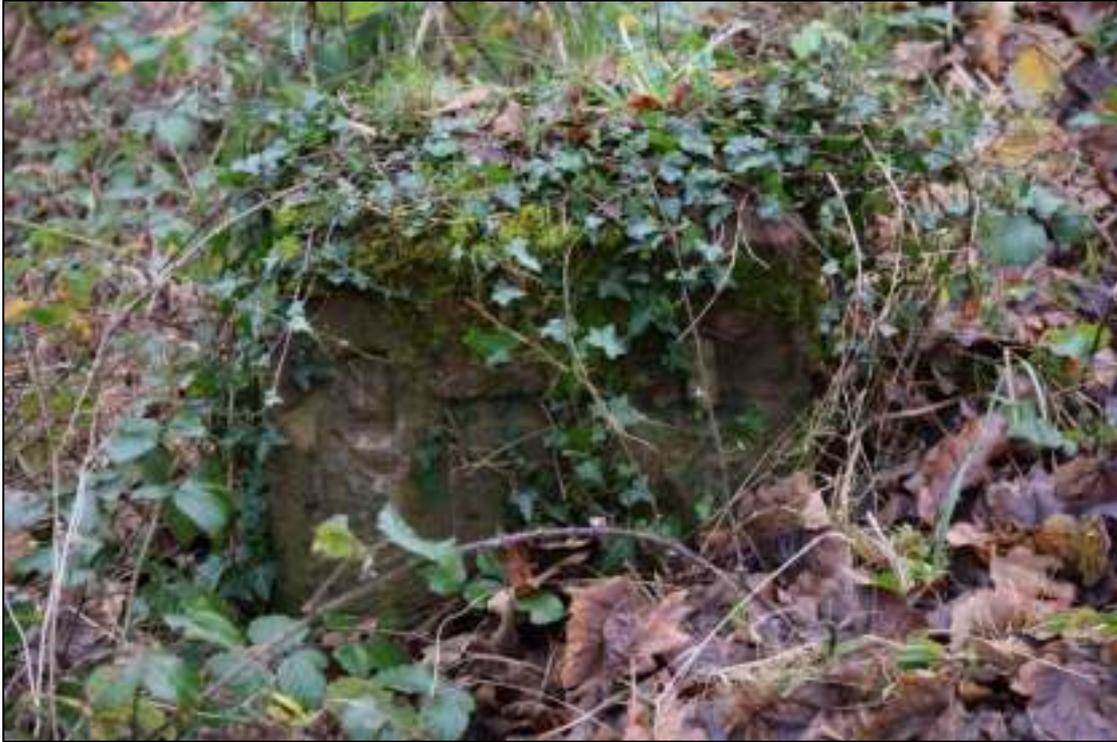
Photograph 7: Slots in the east face of the milestone were used to fix the iron plate with the inscription 'Whitehaven 3 miles'

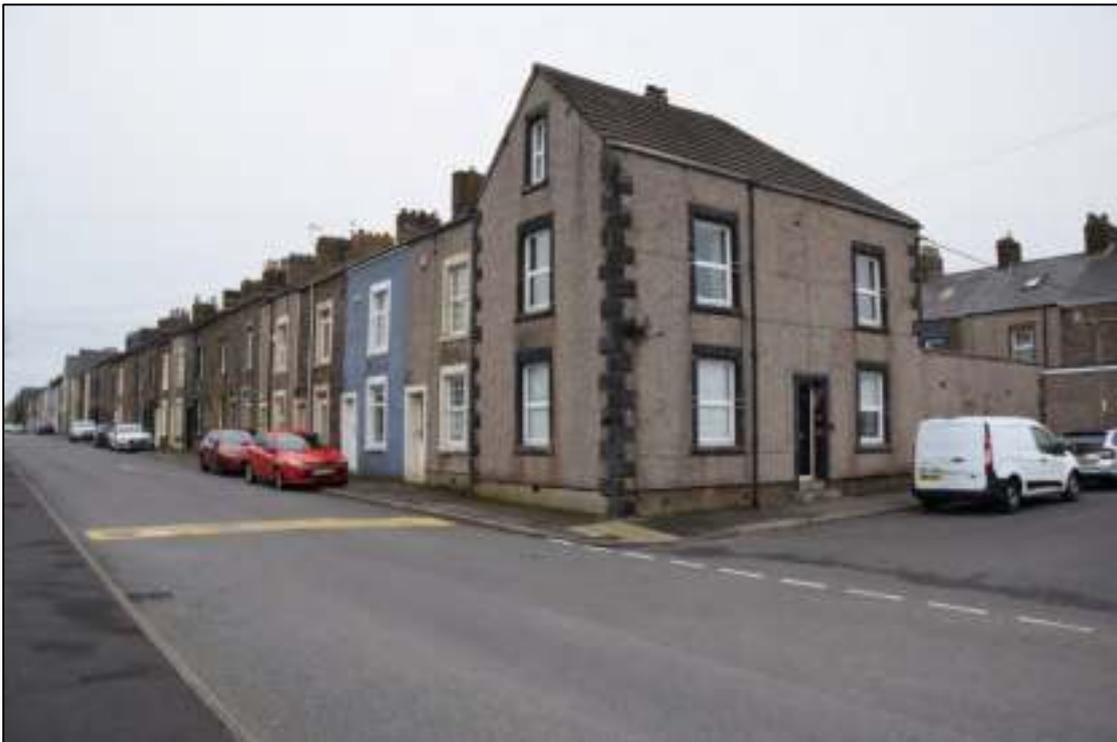
Photograph 8: The houses built by the Moresby Coal Company in 1879-80. A view from the south-west

- 5.4 North-west of the Woods, the original rows of **miners' houses** stand in Moresby Parks (Photograph 8). From the south end of the rows, the **pit road [1]**, laid down in 1879, runs eastwards across the north end of the site (Photographs 9, 10). The old road is still used as a track and a public footpath between Moresby Rugby Club and the main north-south path through Walkmill Woods. The track (but not the right of way) continues east around the north end of the colliery site and eventually to Sands Close farm. An old tarmac surface remains in many places. The principal structural feature within the study area here is a brick culvert that carries the water from Moresby Moss under the road, beside the dam (Photographs 11-13). Low walls that flank the road here contain bricks with the stamp of Micklam brickworks (Photograph 14). This works, now demolished, was north of Lowca, about 3.7km north-west of the dam.

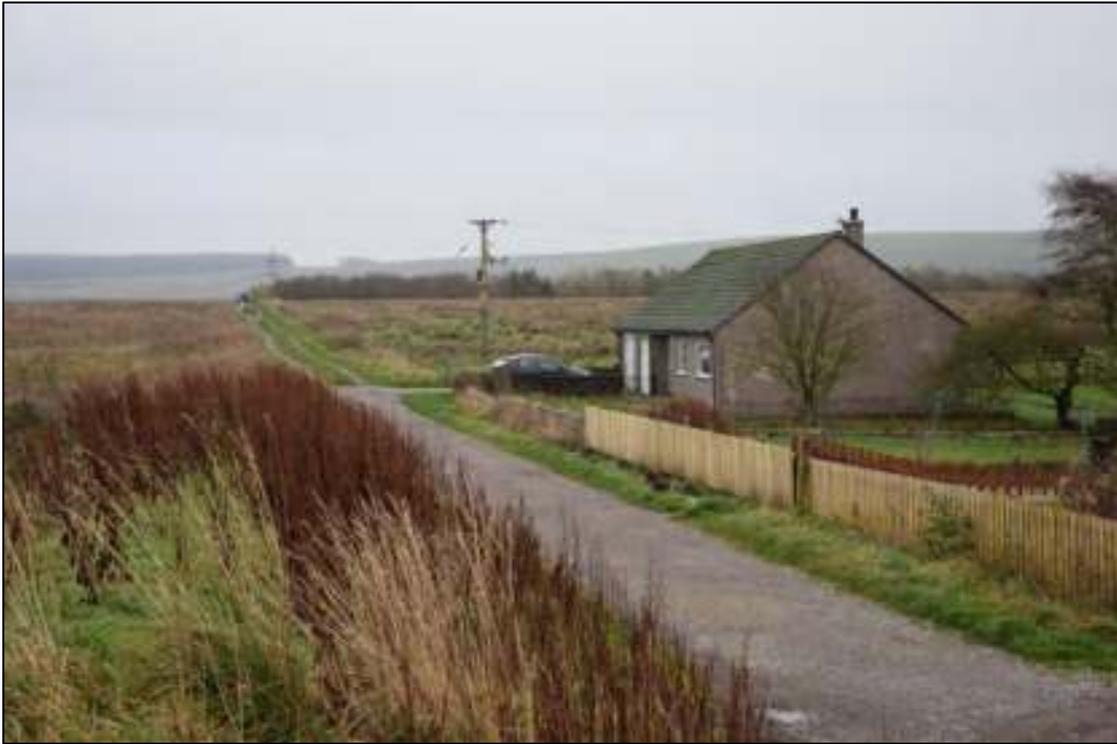
Photograph 9: The pit road [1] running towards the old colliery. The trees in the middle distance are in the north-west part of Walkmill Woods

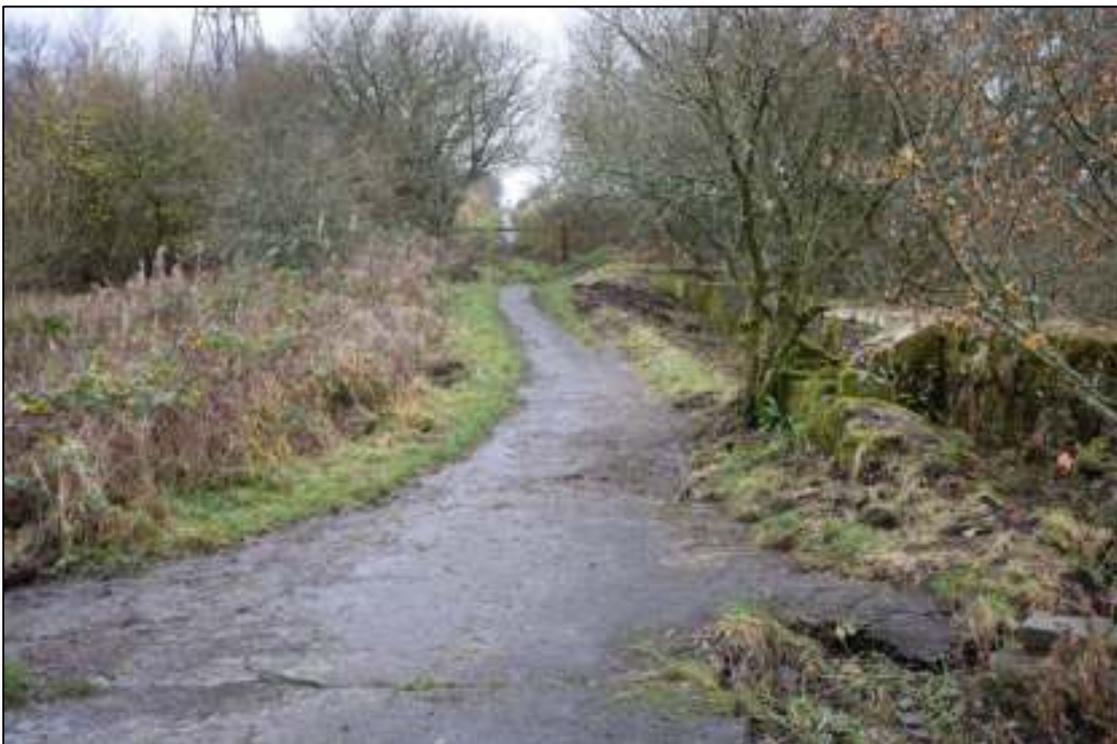
Photograph 10: A view looking west along the old pit road, with the later dam [2] at the right

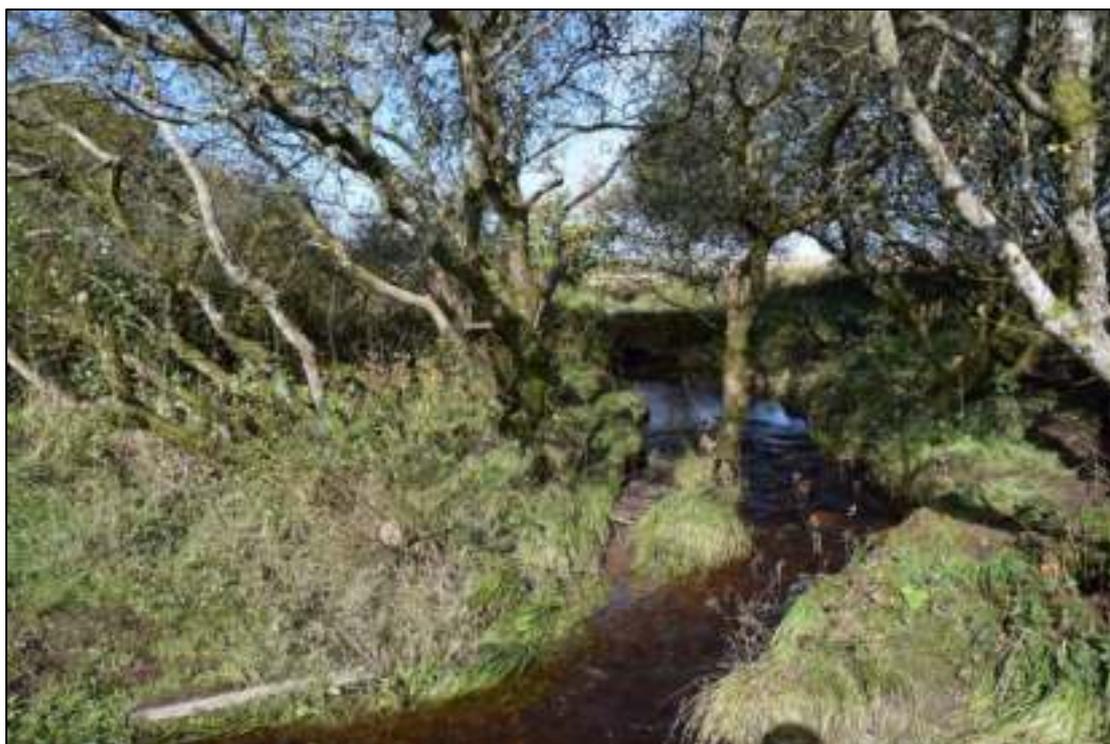
Photograph 11: The beck emerging from the culvert, with the dam in the background. A view looking north

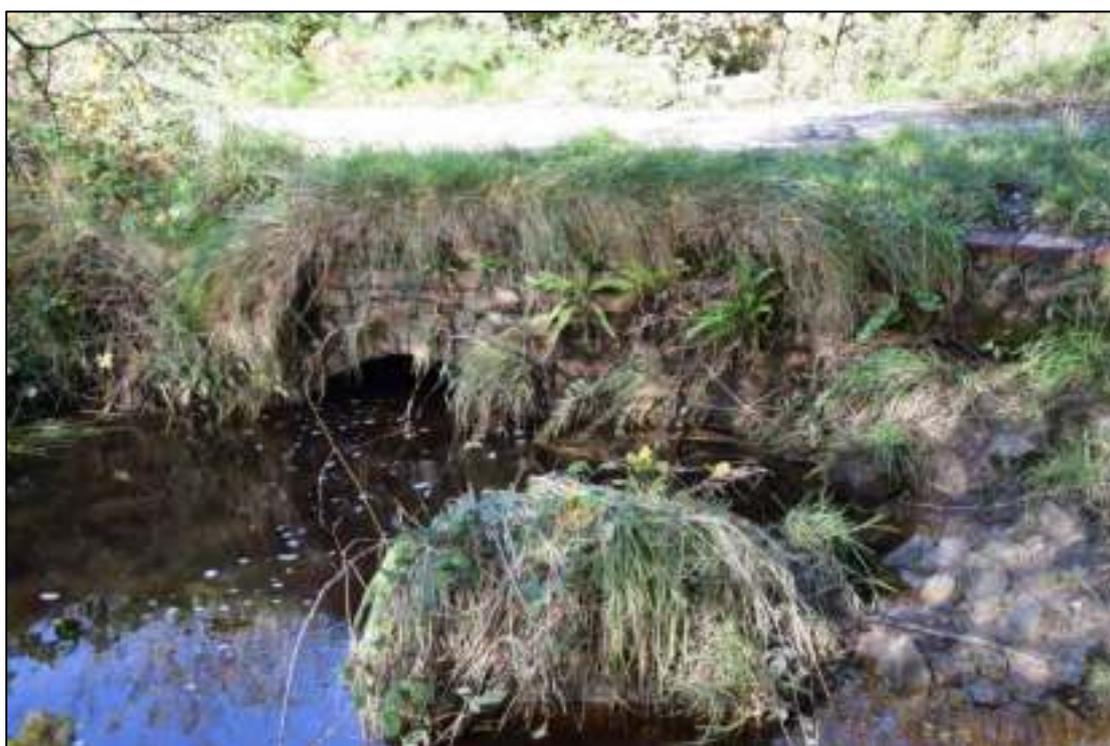
Photograph 12: The south end of the culvert and the low brick kerb on the side of the road

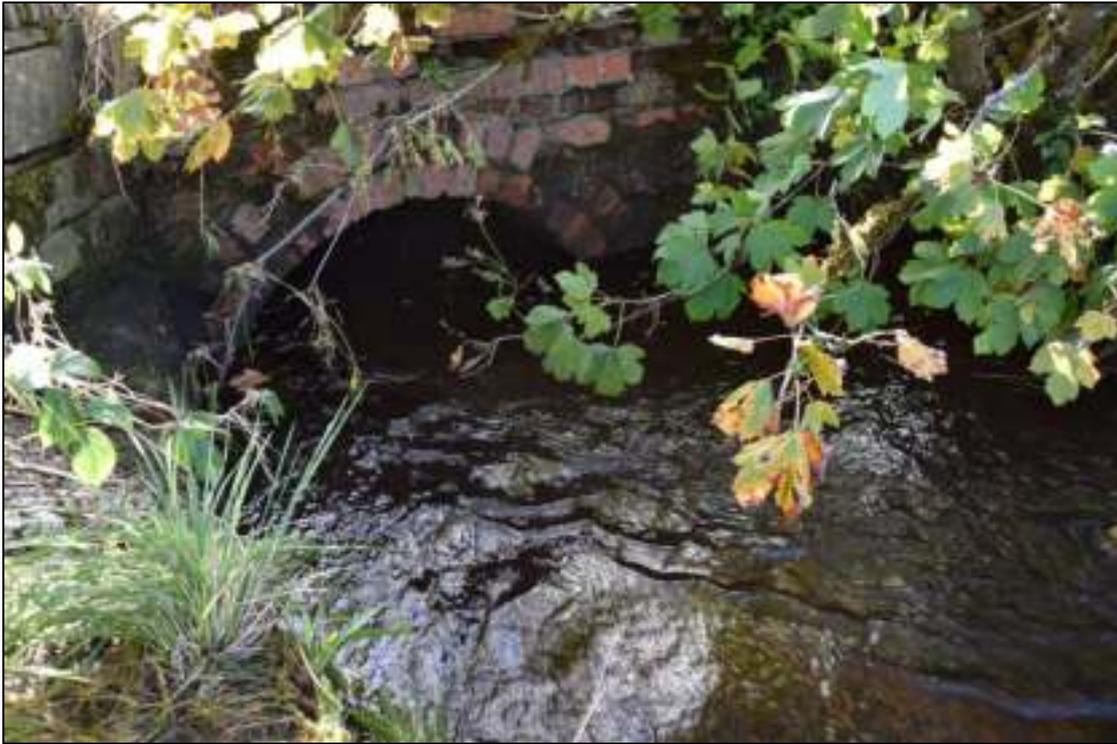
Photograph 13: The north end of the culvert

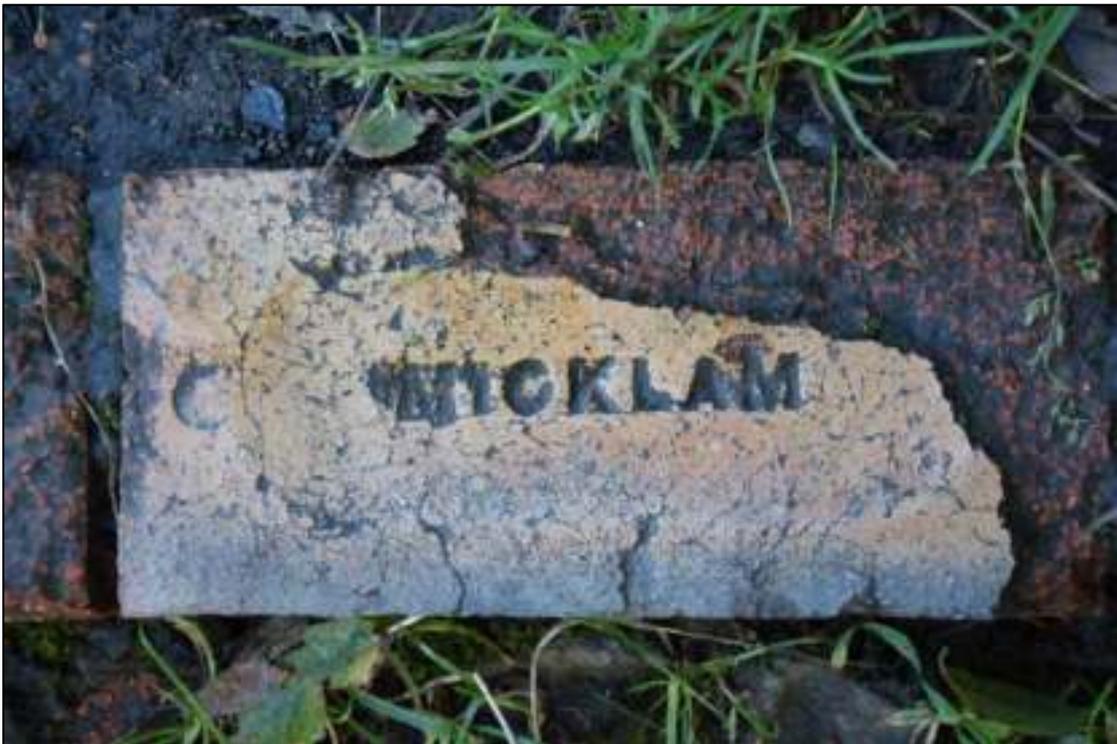
Photograph 14: A Micklam brick in the kerb of the pit road. The brickworks was attached to a colliery not far from Walkmill Woods

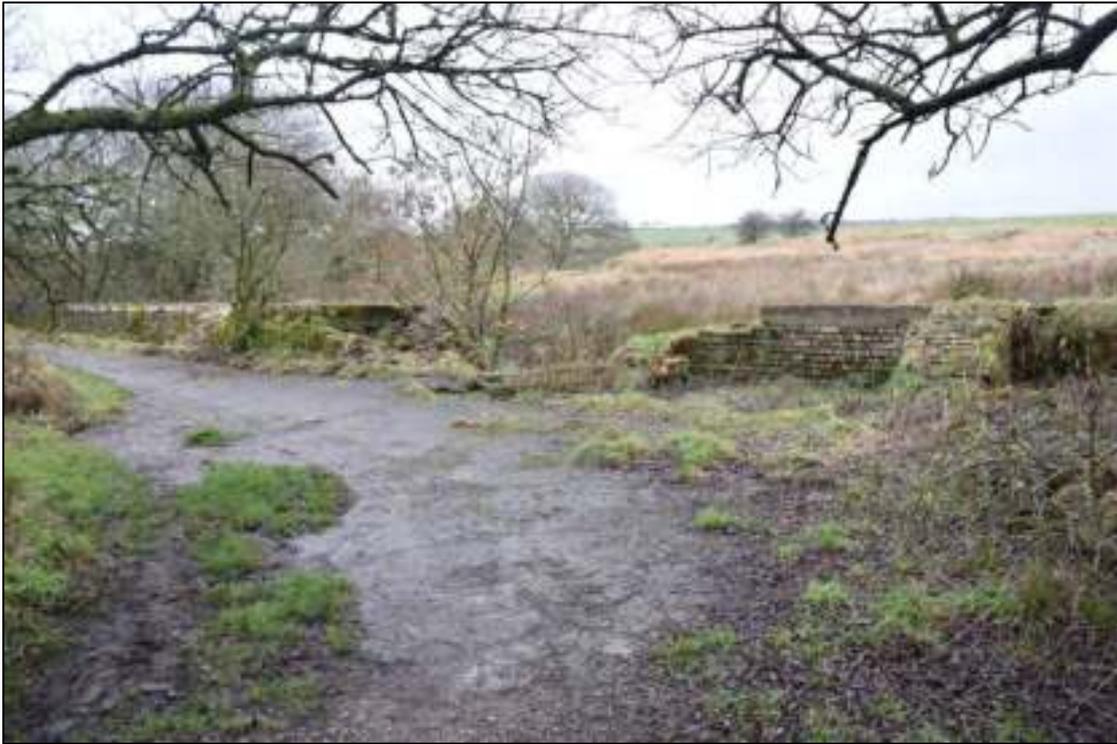
Photograph 15: The brick and concrete dam [2] seen from the south-east. The large gap in the centre of the wall is obvious in this view

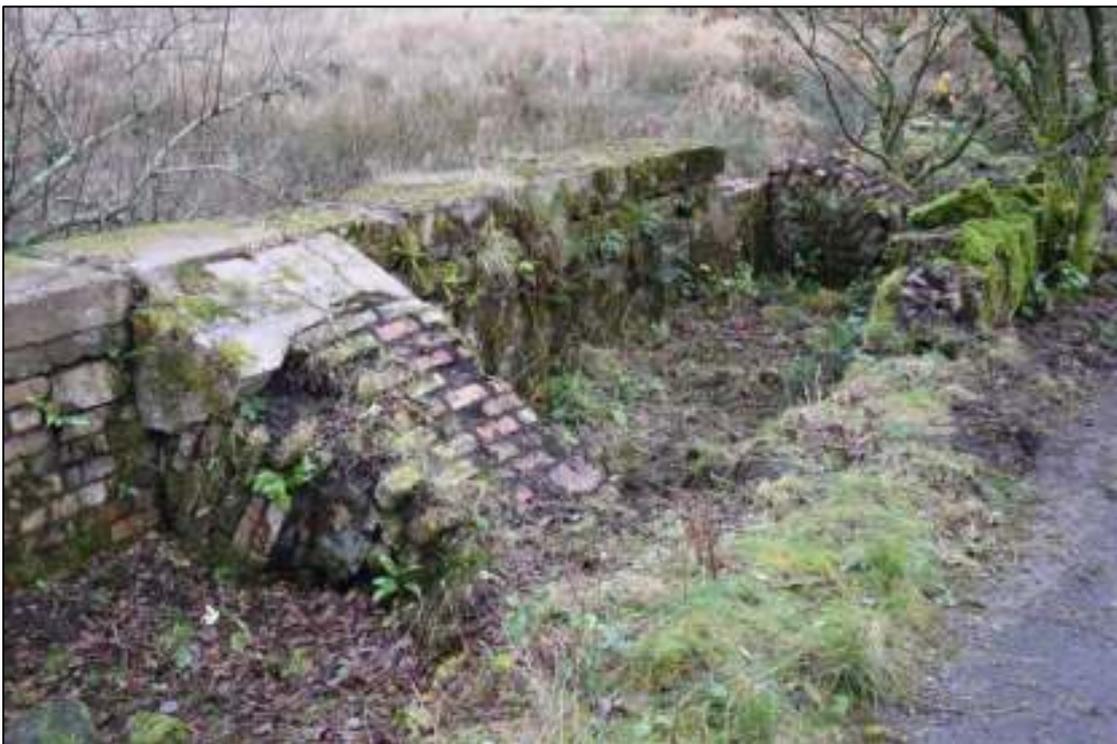
Photograph 16: Buttresses and the dam wall west of the breach, after clearance by volunteers

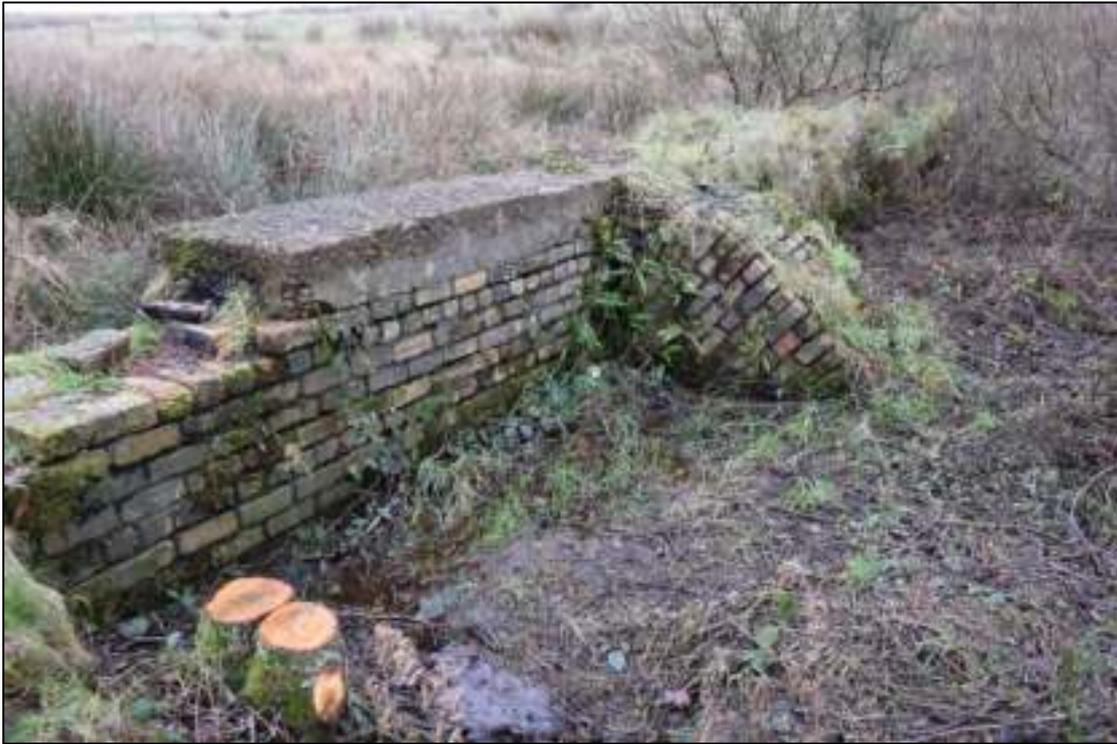
Photograph 17 (above): The same construction on the east side of the breach

buttresses against the embankment of the pit road. A large breach in the middle of the dam shows the thickness of the wall under the water (Photograph 17). The wall was originally lower here to make the spillway of the weir, as marked on the 1925 map. There is a bypass pipe under the dam here, installed to allow water to be drained for maintenance or other work. The tapered stem of the valve on this pipe can be seen just downstream of the dam wall today (Photographs 18, 19). A firebrick made for an arch, vault or other curved structure in a kiln or a furnace was found, re-used, in the dam wall (Photograph 20).

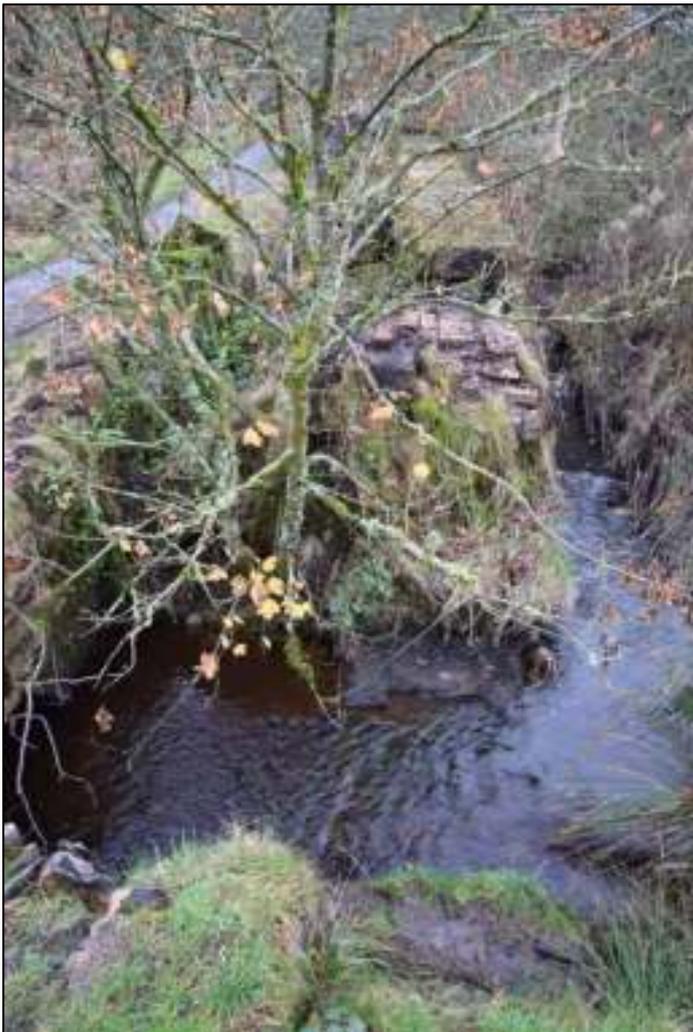
Photograph 18 (left): A view looking west along the dam, with the lower wall of the pit road to its left. Brickwork of the breached dam can be seen under the water, with the stem of a bypass valve to its left

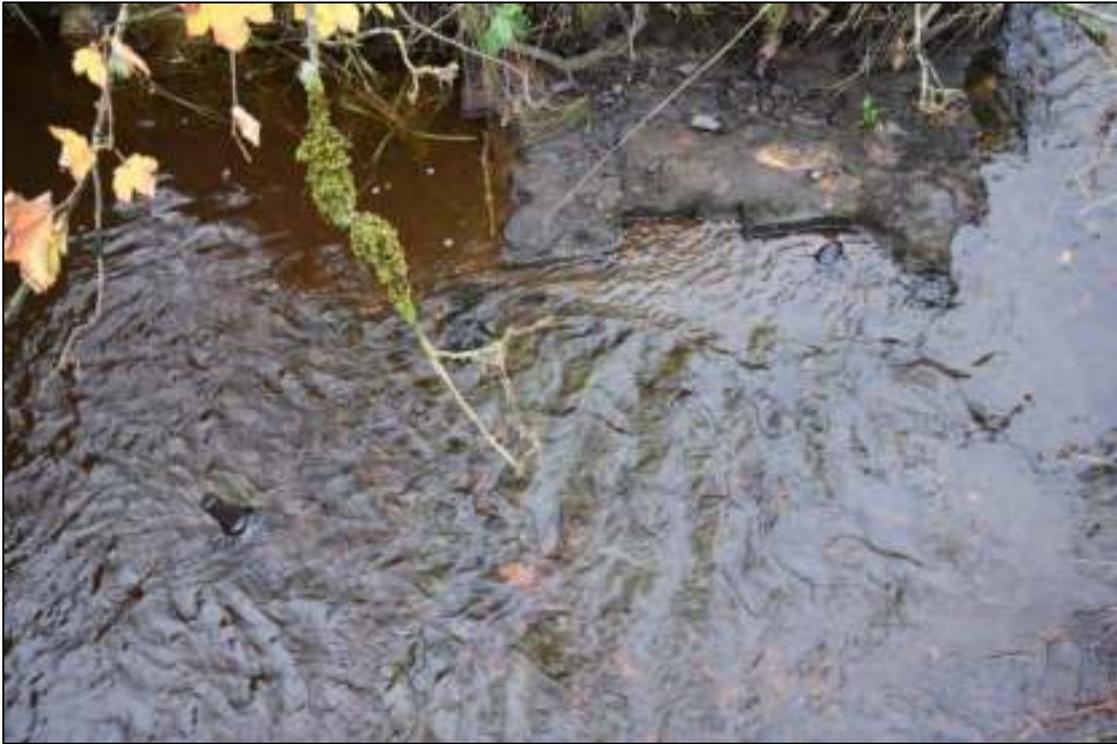
Photograph 19: The tapered end of the valve stem is visible above the water, lower left. A key that was fitted onto this allowed the pool behind the dam to be drained when required

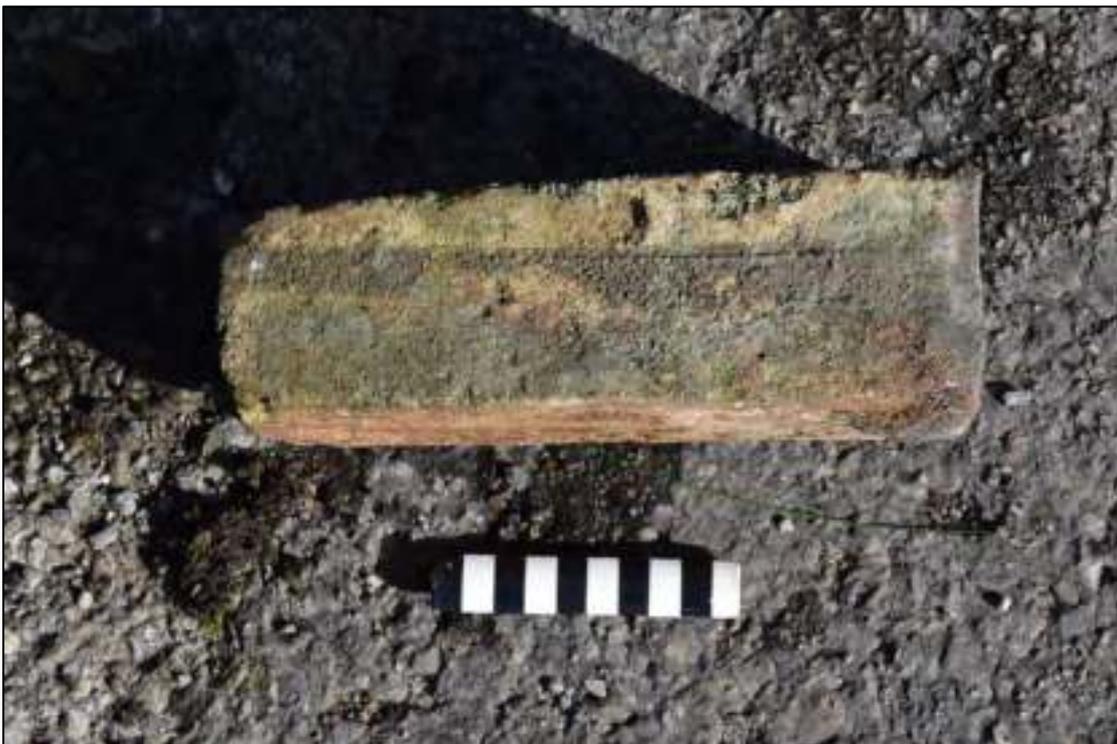
Photograph 20: A tapered firebrick, intended for an arch or vault, found re-used in the dam wall. The scale is 100mm long

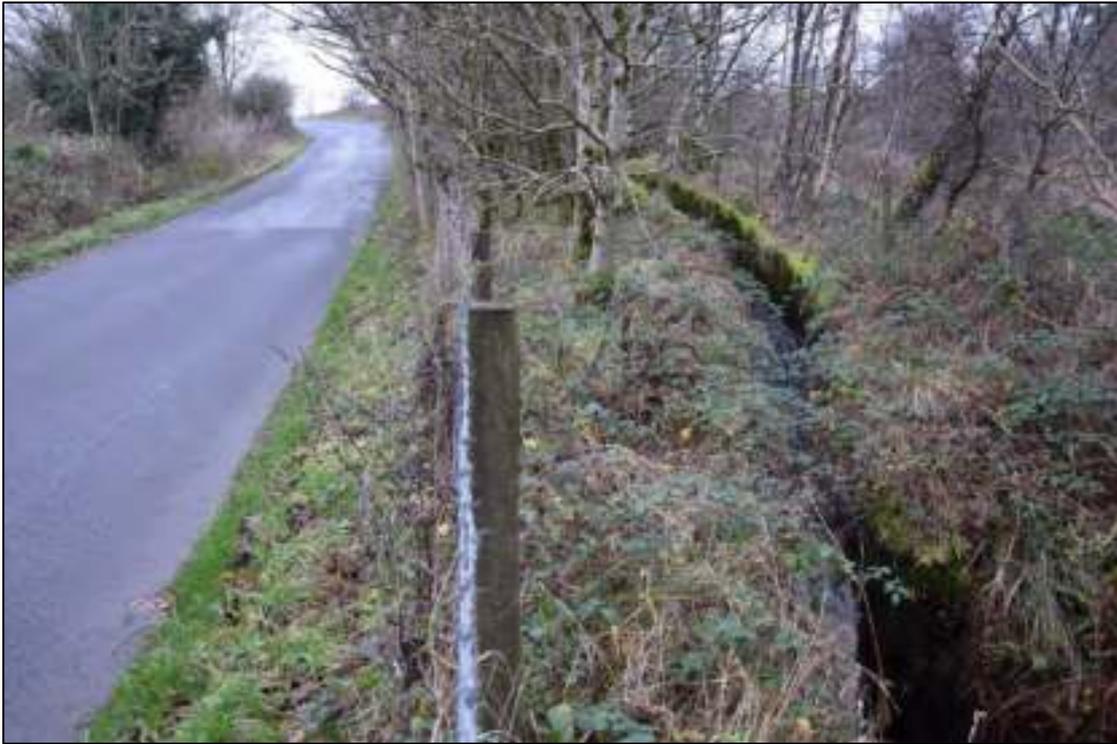
Photograph 21: A moss-covered concrete channel carrying the beck [3] beside the road at the south end of the woods. A view looking west, near the car park entrance

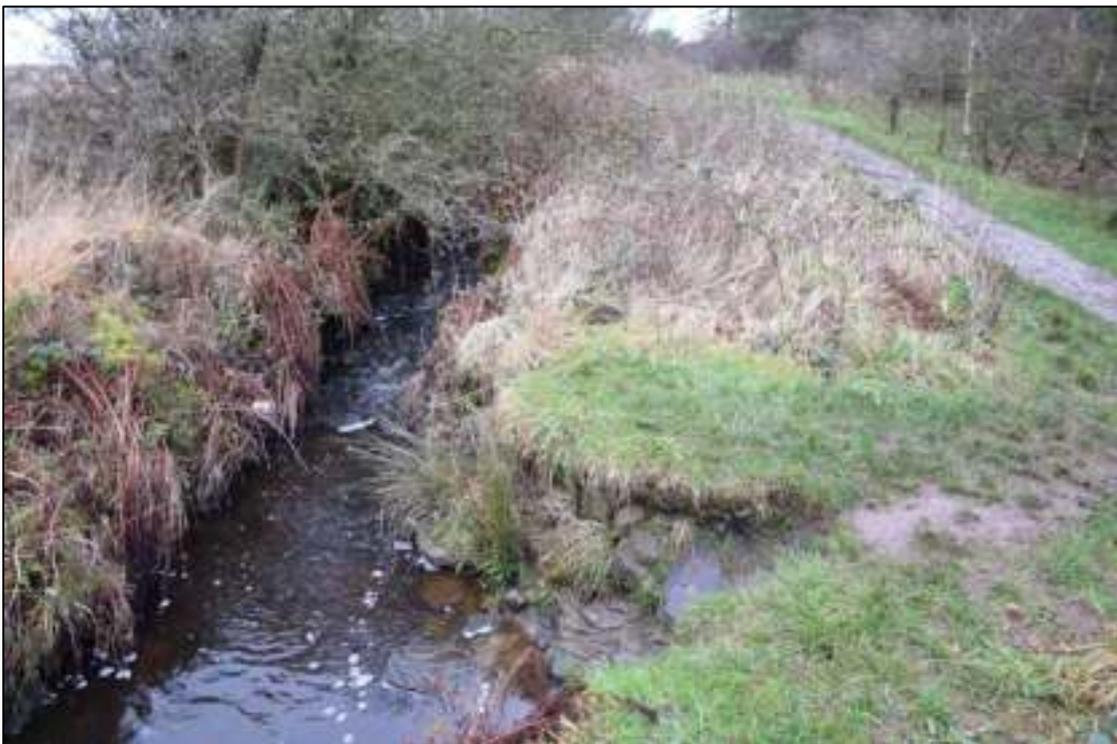
Photograph 22: A mixture of concrete and stone forms the beck channel south of the railway embankment

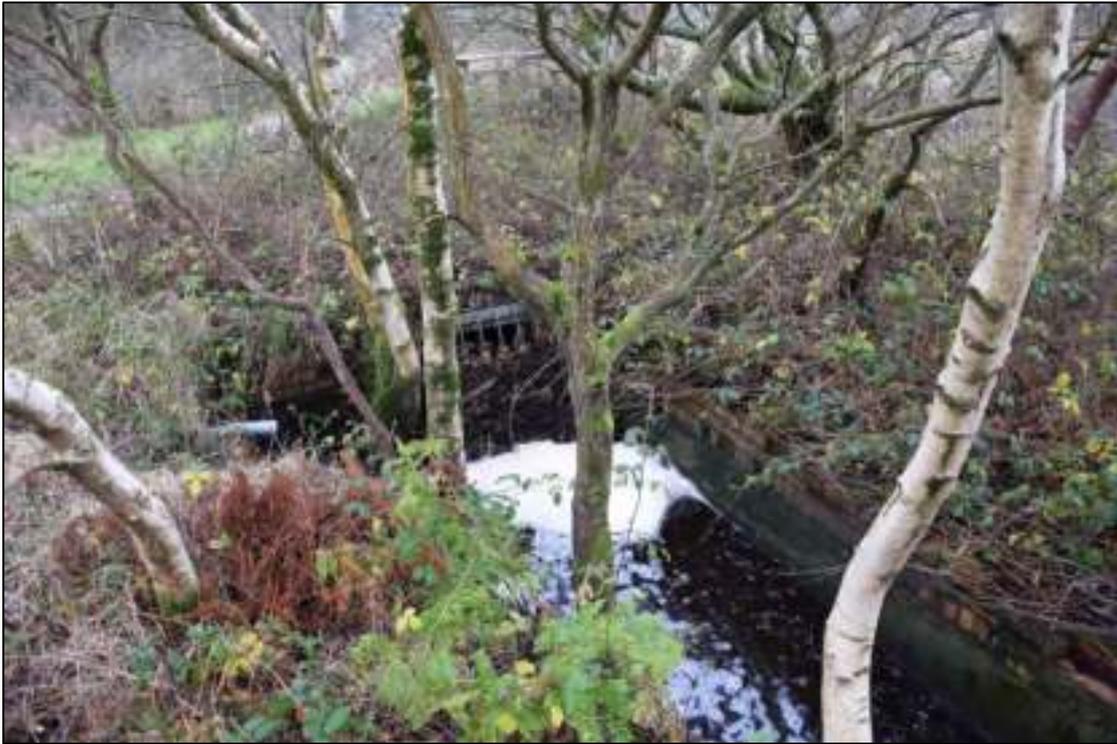
Photograph 23: This deep culvert carries the beck under the old railway line. A view looking south-west

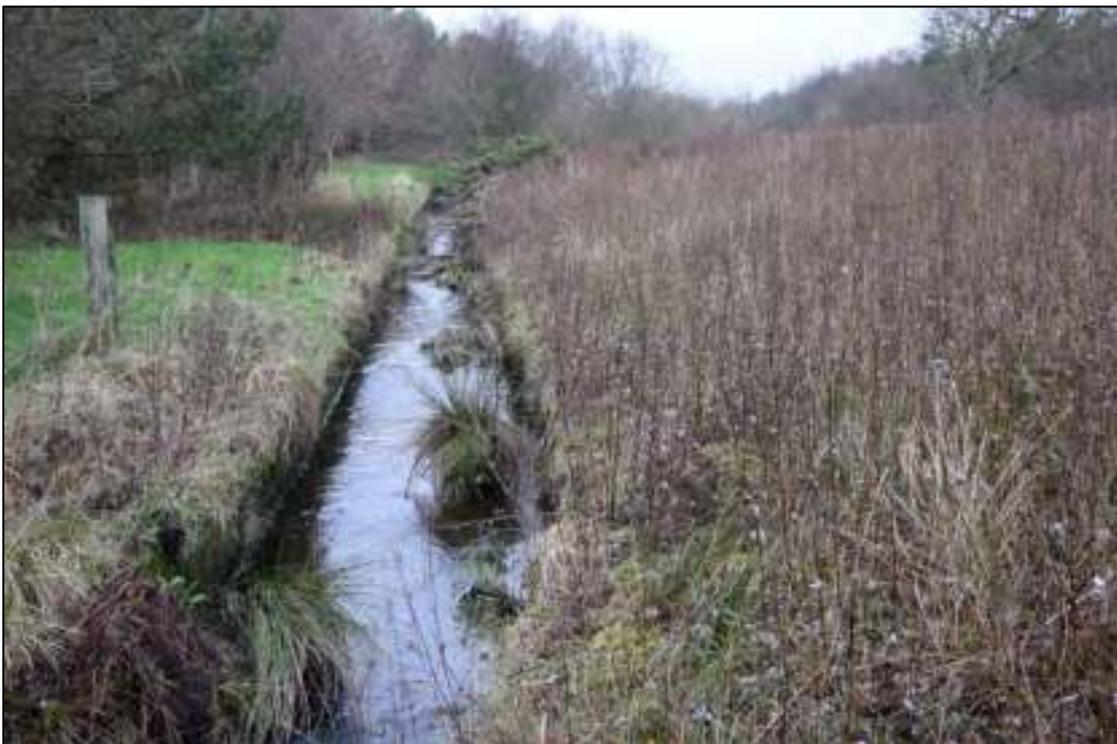
Photograph 24: A typical section of canalised stream a little to the north of the old railway. A view looking north

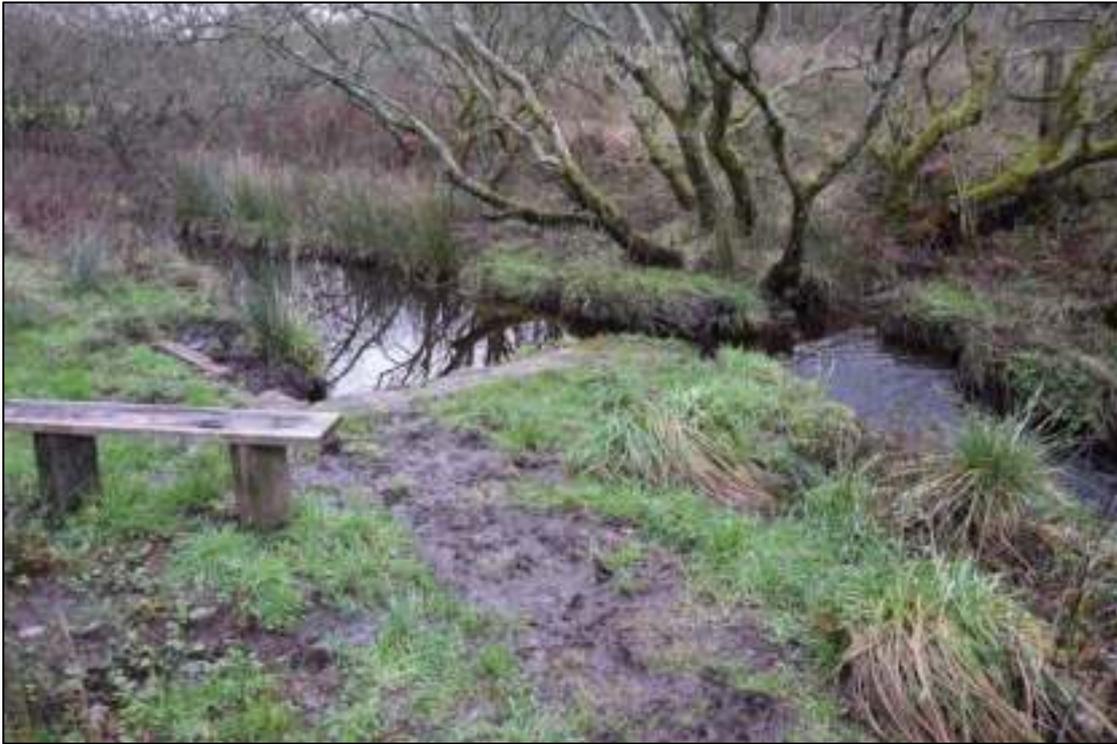
Photograph 25: The remains of a brick weir [4] at the south end of the old mine dam. A view looking north-east

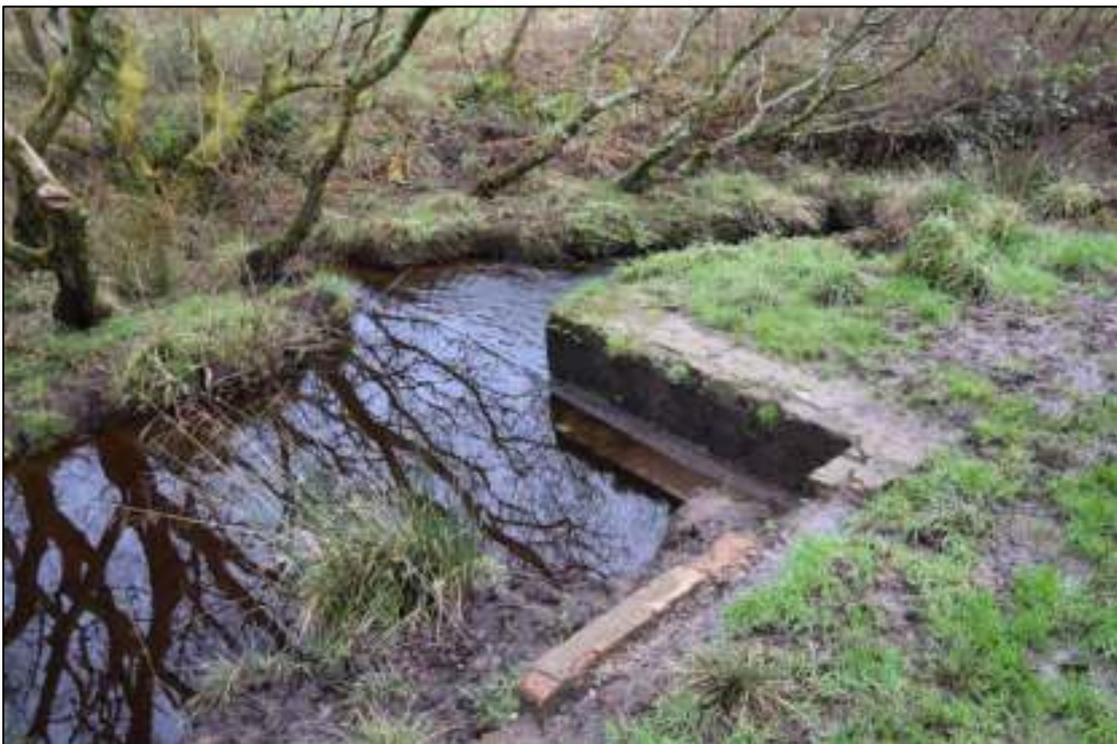
Photograph 26: The same weir structure [4] seen from the north-west
