ARCHAEOLOGICAL
SERVICES
DURHAM UNIVERSITY

Walkmill Woods and Colliery
Moresby
Cumbria

archaeological assessment

report 5879
December 2022

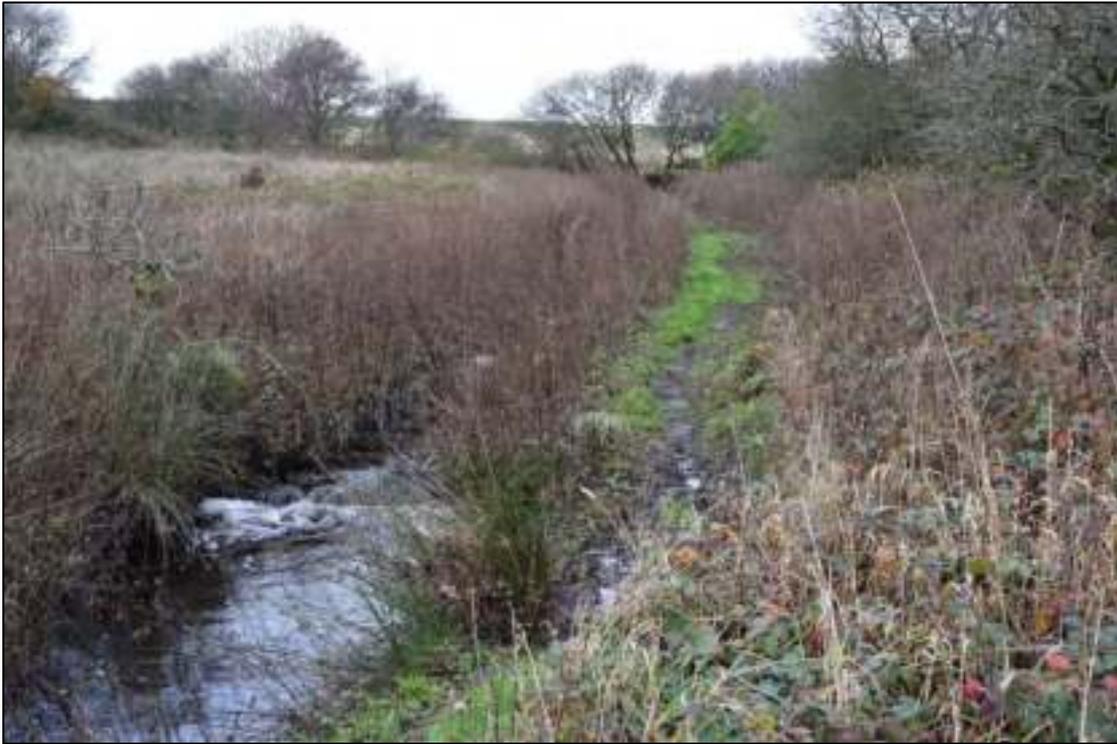
Photograph 27: Looking north along the beck, with the site of Photo 9 in the distance. The semi-natural beck is flowing over the step of a small weir [5], north-west of the site of the mine shafts and boiler house

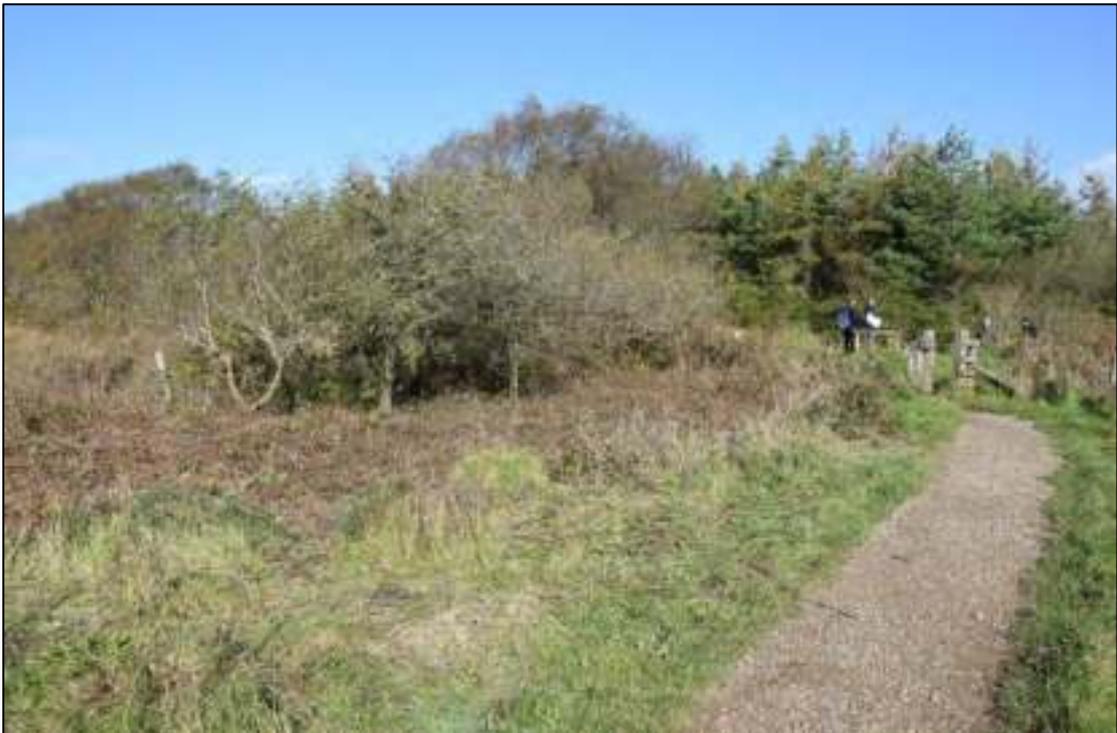
Photograph 28: This footpath runs along the line of the old mineral railway [6] at the west entrance to Walkmill Woods. The remains of the weighbridge building [7] lie under trees and scrub at the left

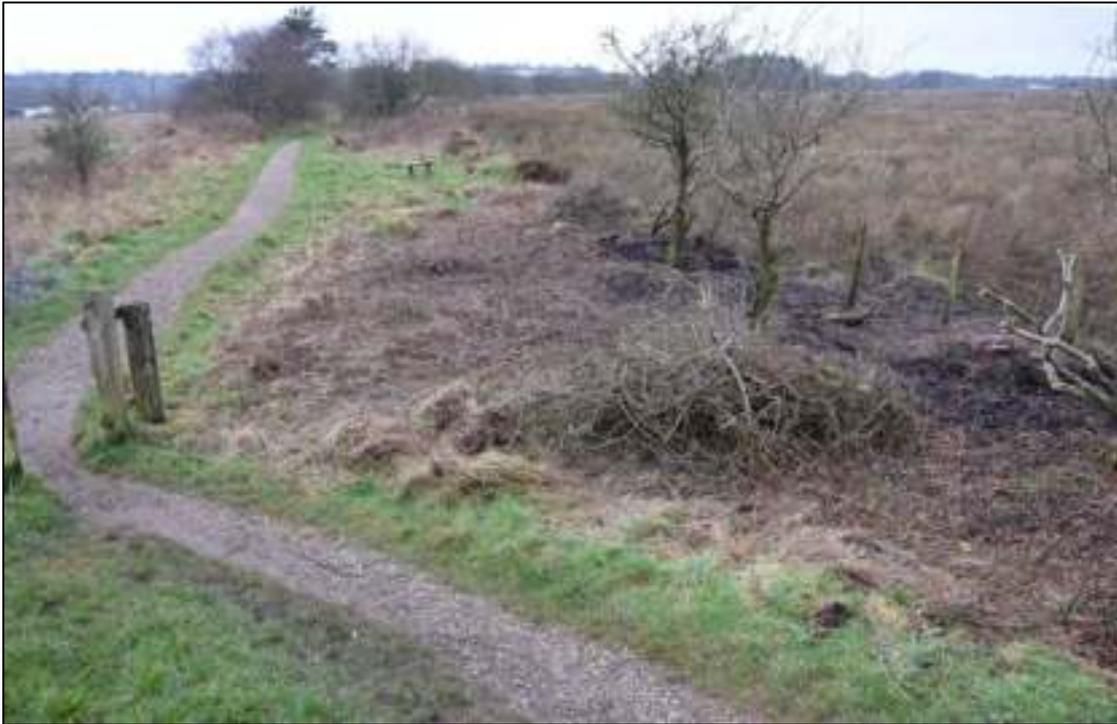
Photograph 29: The same area after clearance, seen from the picnic table at the east side. The low railway embankment [6] is at the left and the remains of the building [7] under the fence at the right

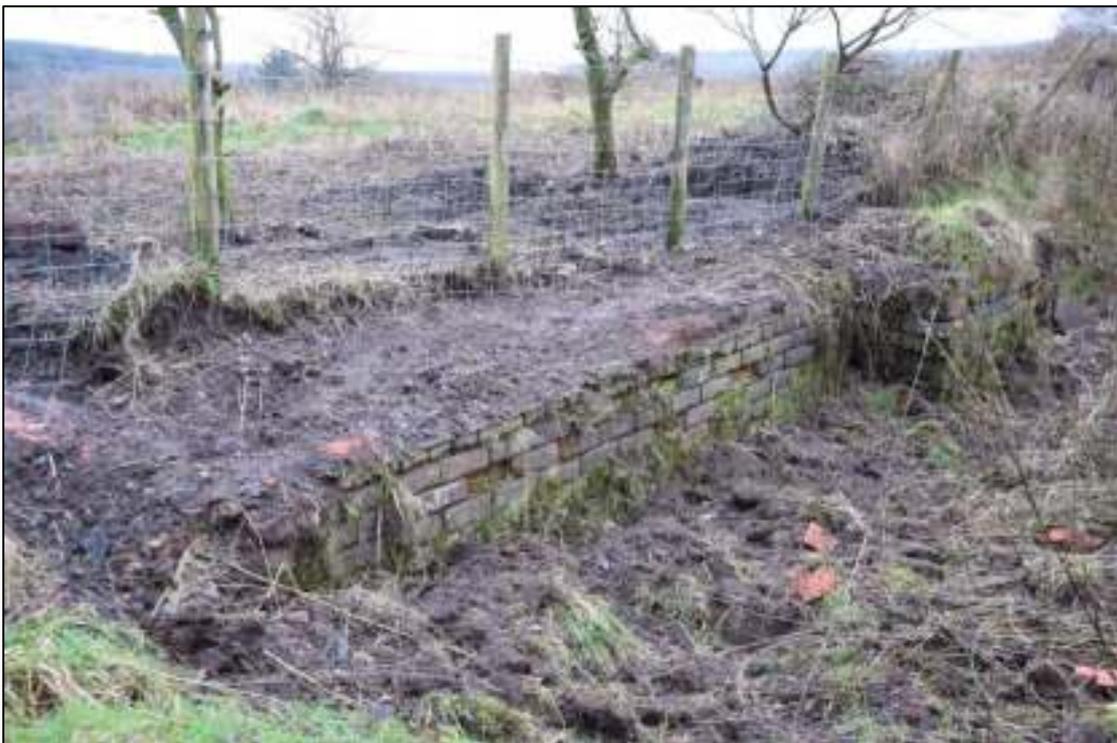
Photograph 30: The north wall of the old weighbridge building [7]. The projection at the right is at the end of the beam trench that linked the building to the platform on the rail line

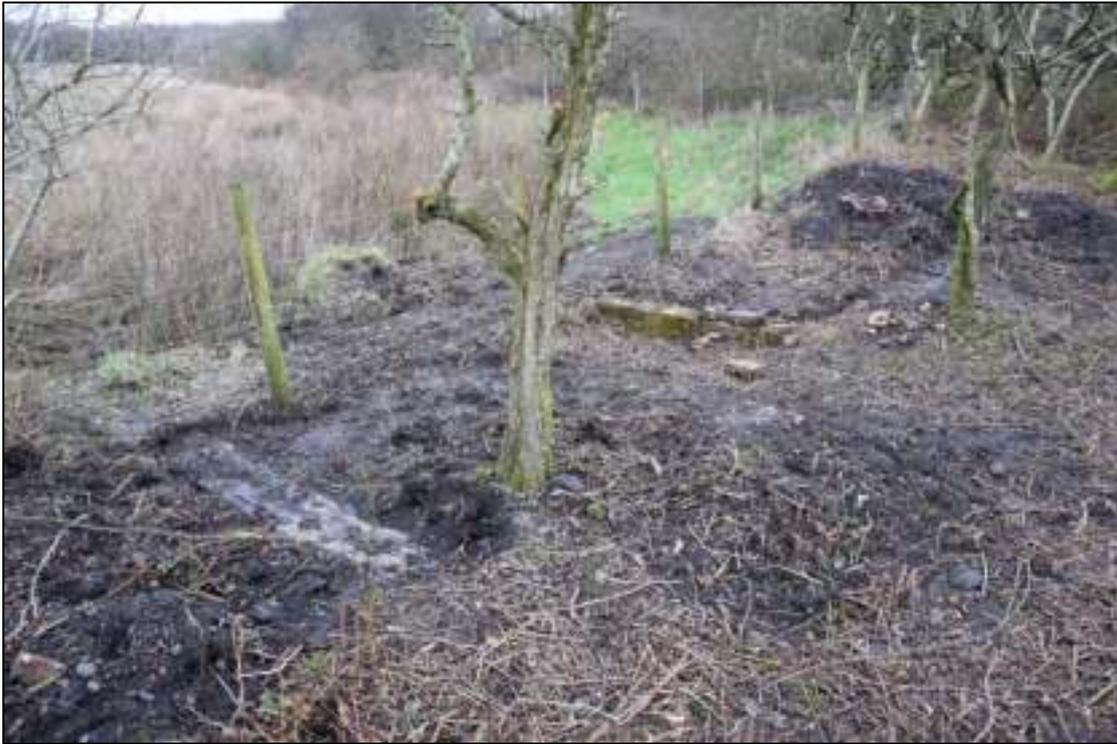
Photograph 31: The weighbridge building after clearance by Green Gym volunteers. A view looking north-east

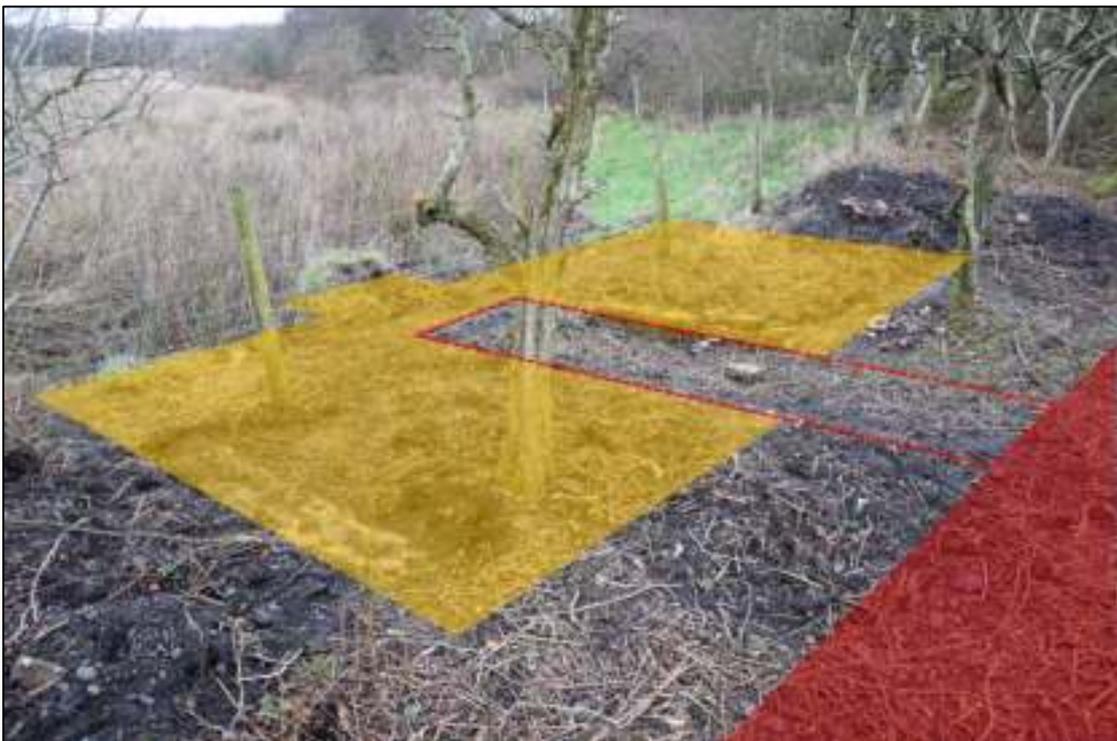
Photograph 32: The same view with the approximate site of the weighbridge platform shown in red shading. A trench, marked by the dotted red outline, held a balance beam that linked the platform to the weighing mechanism and weight dial inside the building, the shape of which is shaded in yellow

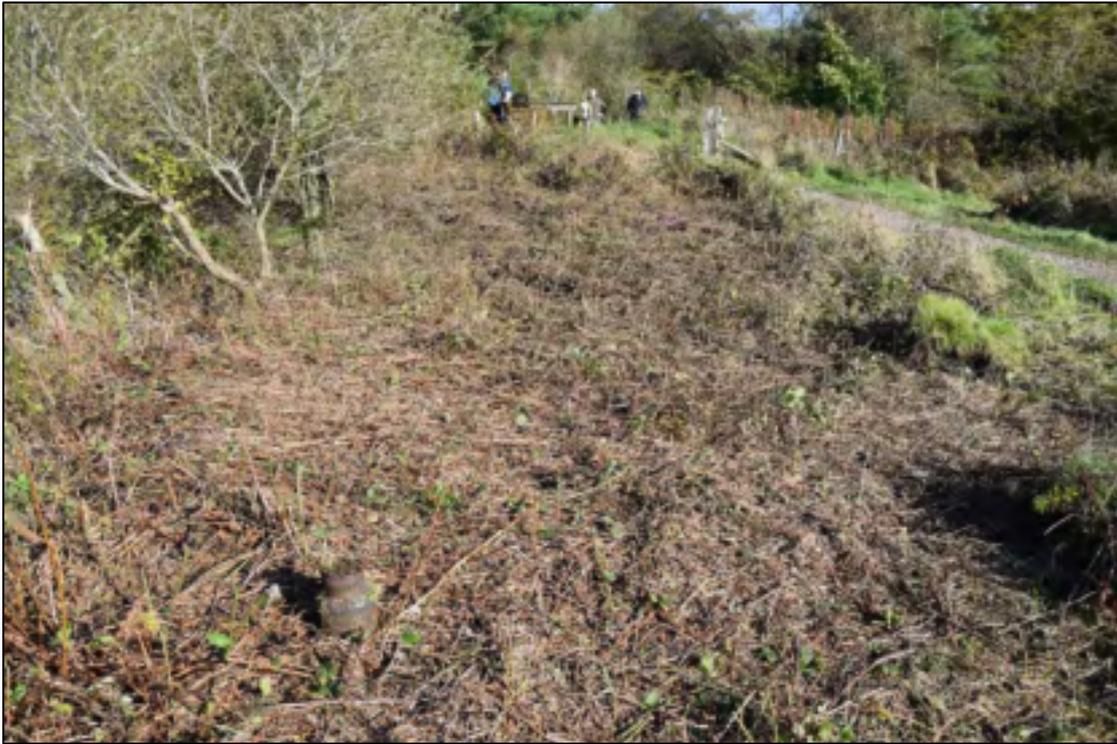
Photograph 33: Looking east across the weighbridge site in October 2022. The stump of a steel post can be seen in the foreground; this was probably connected with the business of weighing loaded wagons leaving the colliery

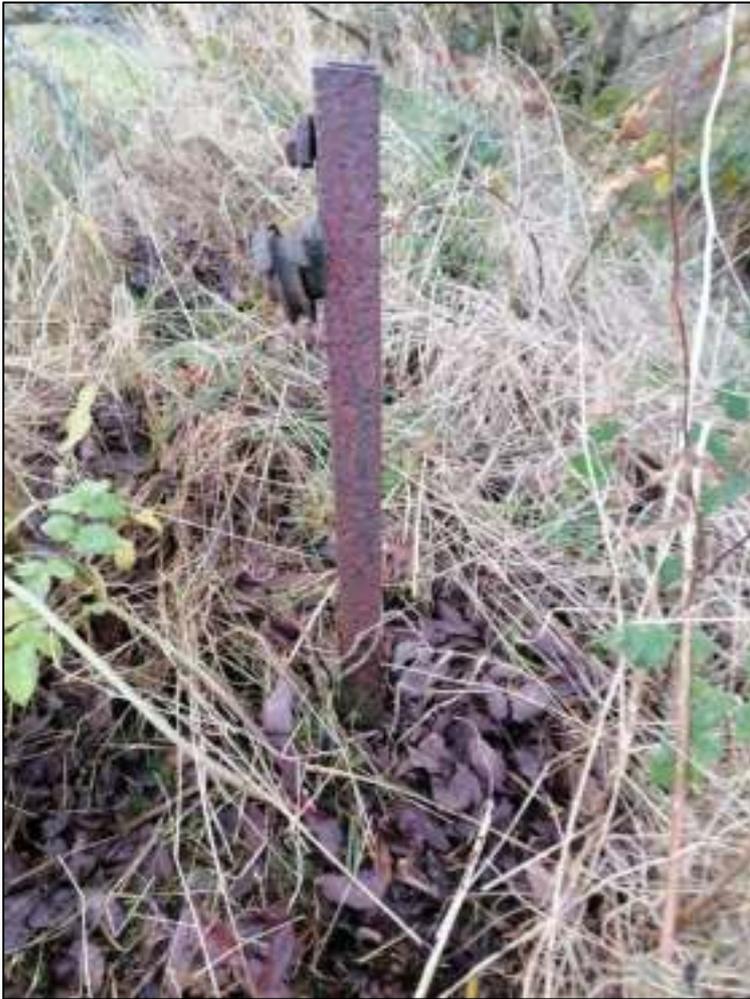
Photograph 35 (left): One of the posts that carried cables that connected the box shown above to a signal on the mineral line. This was to control traffic from the colliery as it joined the main railway line

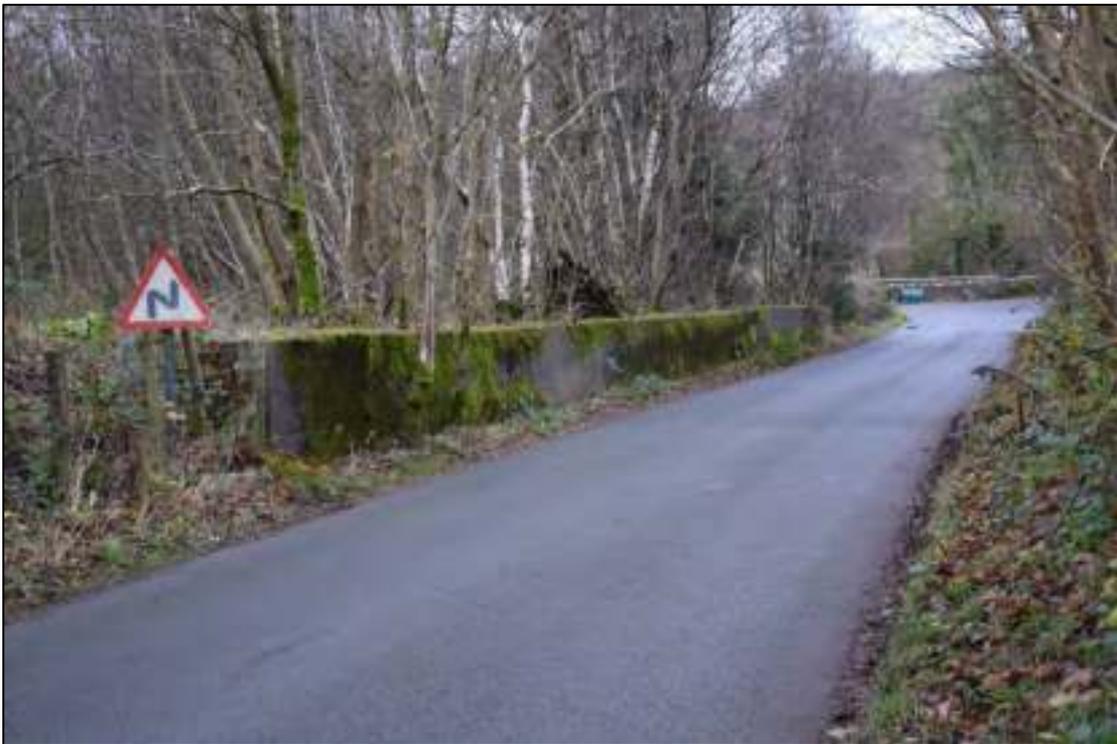
Photograph 36 (below): A substantial concrete wall [8] built to contain the south end of the pit heap. A view looking east towards Walkmill Bridge

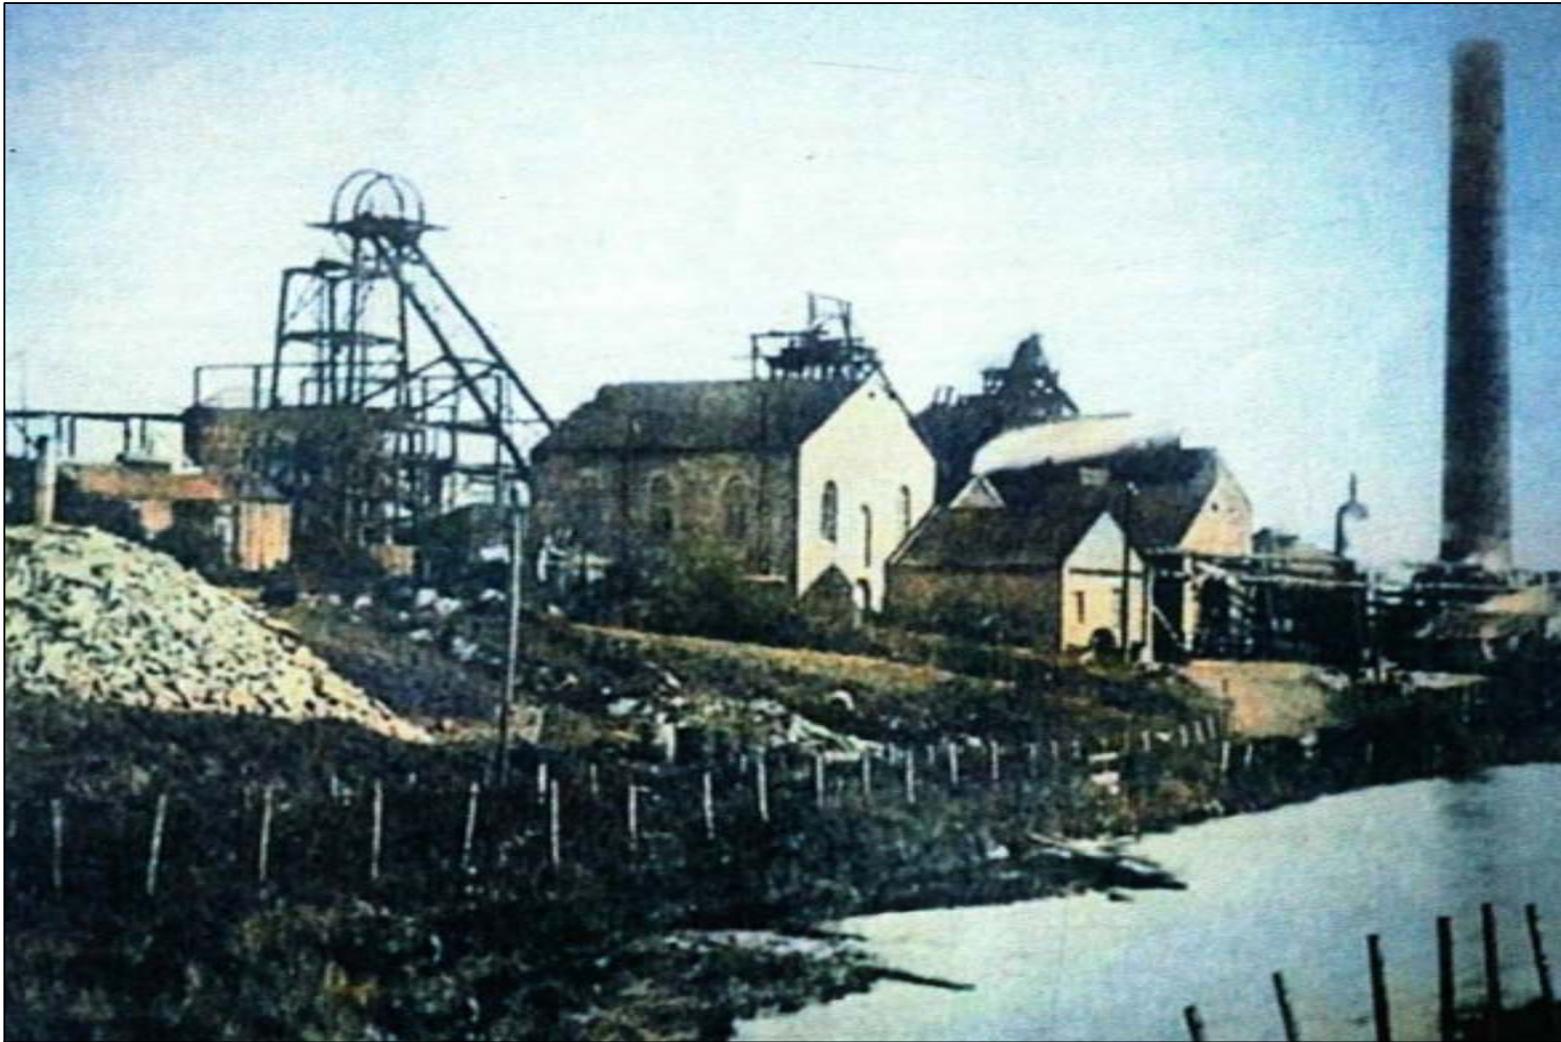
Figure 8: Early 20th-century postcard view of Walkmill Colliery. The headgear of the shafts can be seen, together with the northern winding house and one of the boiler chimneys. The coke ovens are out of shot to the right; the water in the foreground is an artificial pool known as 'the dam'. A view looking south-east.

One of these chimneys is shown, along with the headgear over the two shafts, in a postcard view of the mine (Figure 8).
