Walkmill
Community
Woodlands

Conservation Management & Maintenance Plan

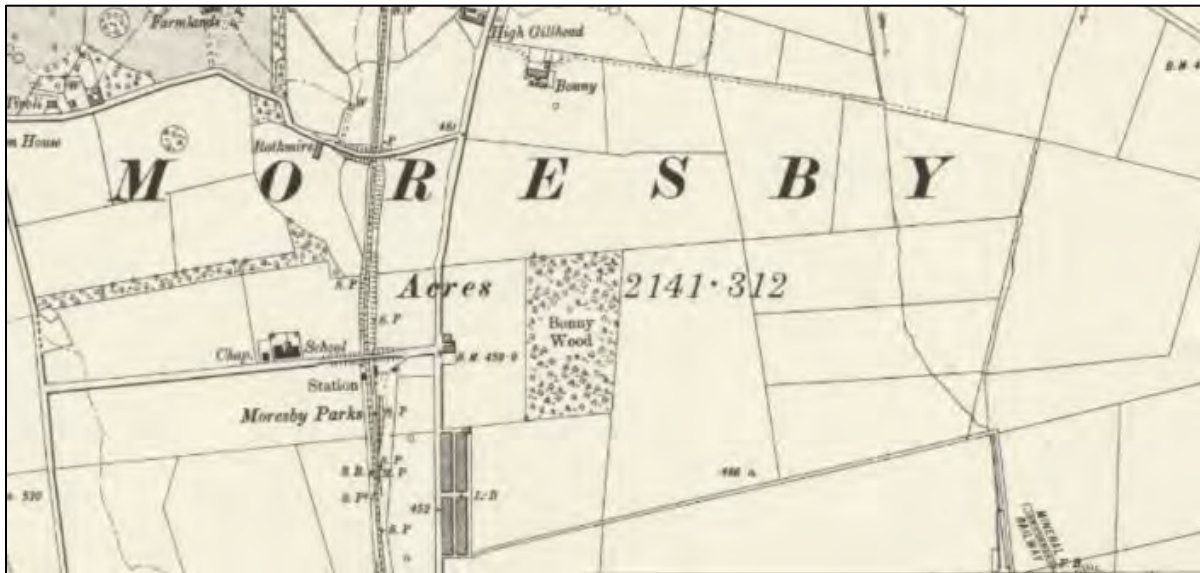
Figure 2.4: Extract from the second edition Ordnance Survey map, 1900

from 371 in 1801 to 1144 in 1891⁸. The second edition Ordnance Survey map of 1900⁹ (see figure 2. 4 below) shows the beginnings of Moresby Parks village in the area north of Moresby Parks Farm. By 1898 the village had a railway station, a school and a chapel. The map also shows four terraces of houses built by the Moresby Coal Company for the workforce. These terraces are still present in Moresby Parks today.

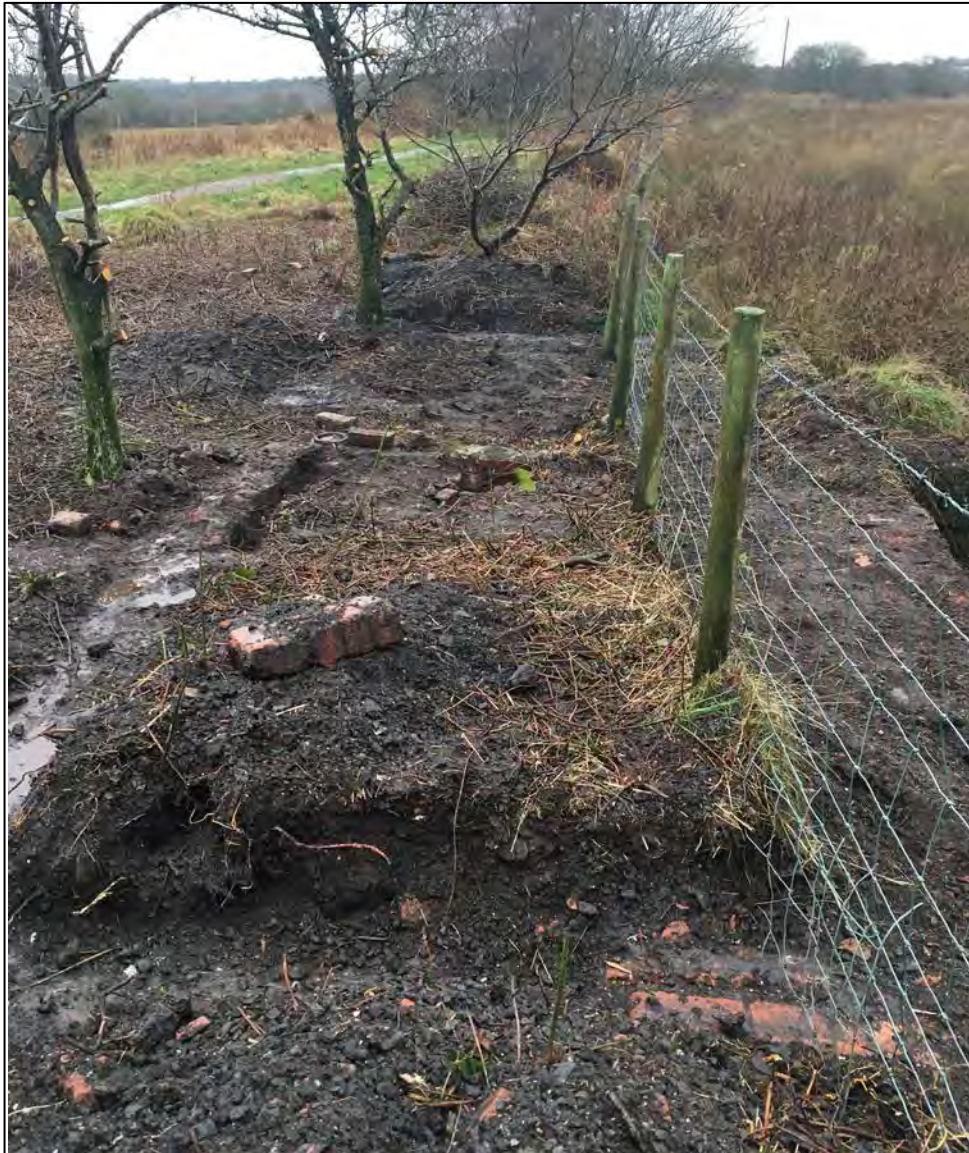
Figure 2.6: The remains of the weighbridge at Walkmill Community Woodland

2.4.1 By 1930 Walkmill Colliery had expanded with more buildings, mine workings, a much larger slag heap and the addition of an aerial ropeway which was used to take spoil to the top of the slag heap. The third edition Ordnance Survey map of 1925¹⁰ (see figure 2.5 above) also shows features whose remnants are on the Walkmill Community Woodland site today, such as the weighbridge¹¹ which was used to weigh wagons loaded with coal or coke as they left the colliery and was installed in 1913. Figure 2.6 below shows the remains of the weighbridge today that was uncovered by volunteers during the development phase.

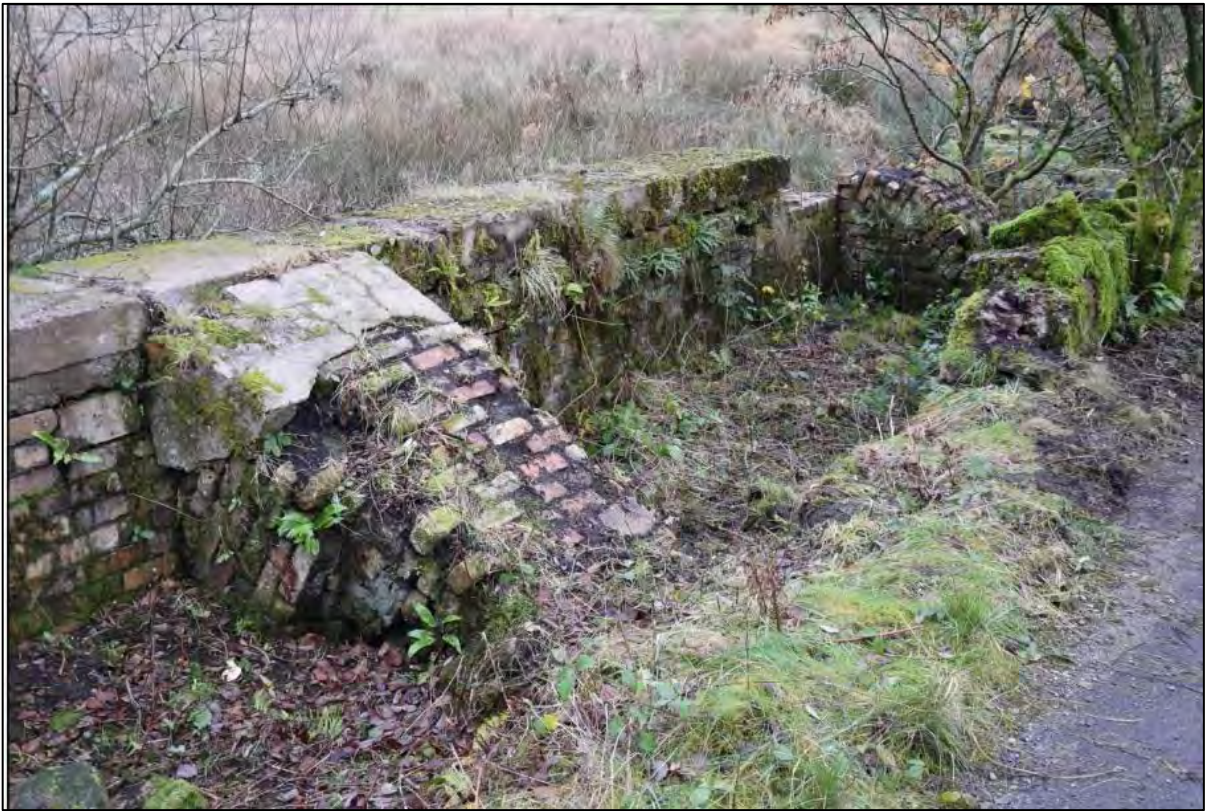
Figure 2.7: The remains of the brick and stone weir at Walkmill Community Woodland

2.4.2 The small section of woodland that had remained in 1899 was felled to make space for the expanding slag heaps, leaving no areas of woodland on the Walkmill Colliery site. Further modifications had also taken place on the beck. The big pool had been drained and is marked on the map simply as ‘mud’. The beck had also been engineered to go around the western side of where the pool had been in an artificial concrete channel, which is the same channel the beck travels through today (see section ‘4.6 Hydrology’ for further information about the current state of the beck). There is also the addition of a waterfall at the southern area of the beck. The map also shows that a new weir and dam had been constructed just north of the ‘pit road’, which created a pool that fed the long pond or dam near the shafts and boiler house. This weir was a brick and stone structure and is still present at Walkmill Community Woodlands today and was also uncovered by volunteers during the development phase of the project – see figure 2.7 below.

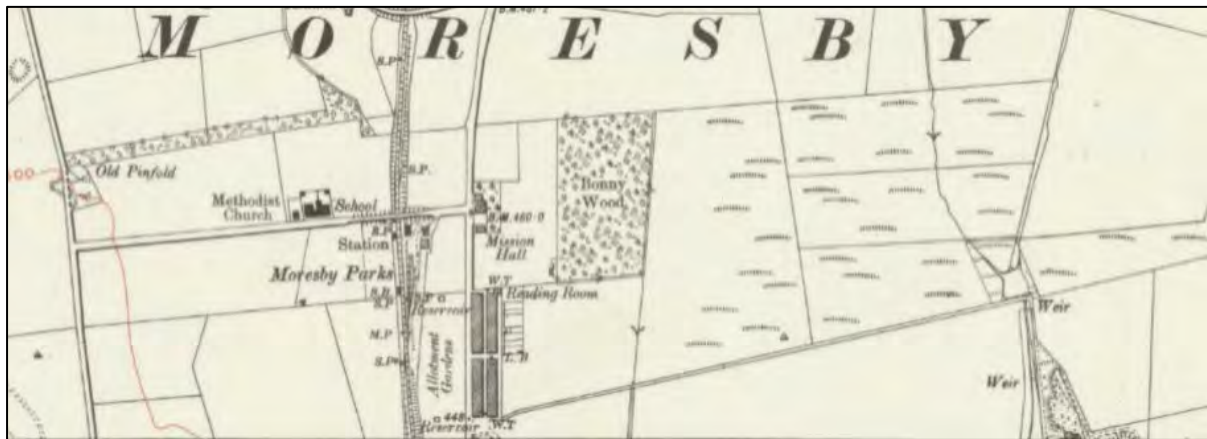
Figure 2.8: Extract from the third edition Ordnance Survey map, 1926

2.4.4 The growth of the Colliery and increase in employment also had an impact on the nearby village, Moresby Parks. The village expanded further with new private dwellings built to the south of the existing school and chapel. There was also the addition of the Mission Hall (a place of worship), Reading Room and Allotment Gardens. See figure 2.8 below showing an extract of the third edition Ordnance Survey map from 1926¹³.

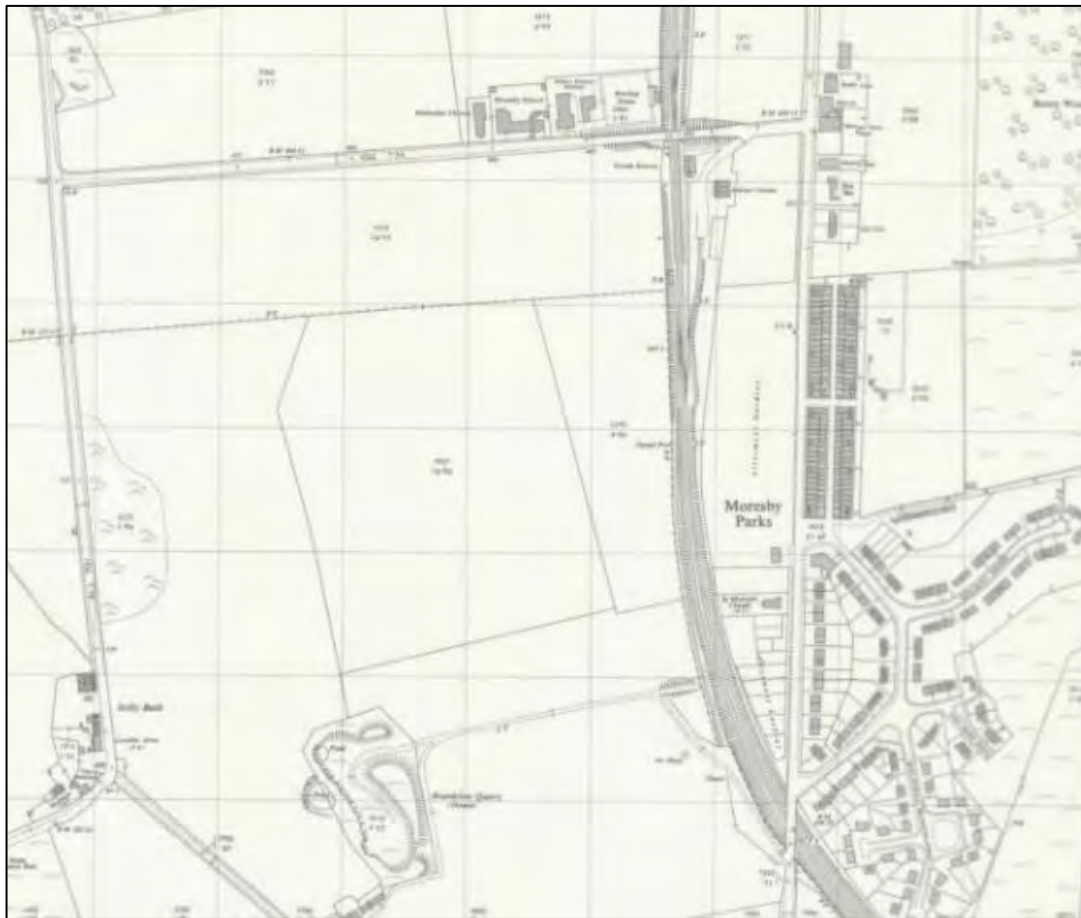
Figure 2.9: Extract from the Ordnance Survey map, 1961

2.5.2 Despite the decline in the number of people employed by the mine, Moresby Parks village continued to expand and the Ordnance Survey map from 1961¹⁸ (see figure 2.9 below) shows a significant increase in housing. It also shows the addition of a new bowling green, St Michael's Chapel and a Miners Welfare Institute. St Michael's Chapel is still present at Moresby Parks today and the Miner's Welfare Institute has become Moresby Rugby Club.

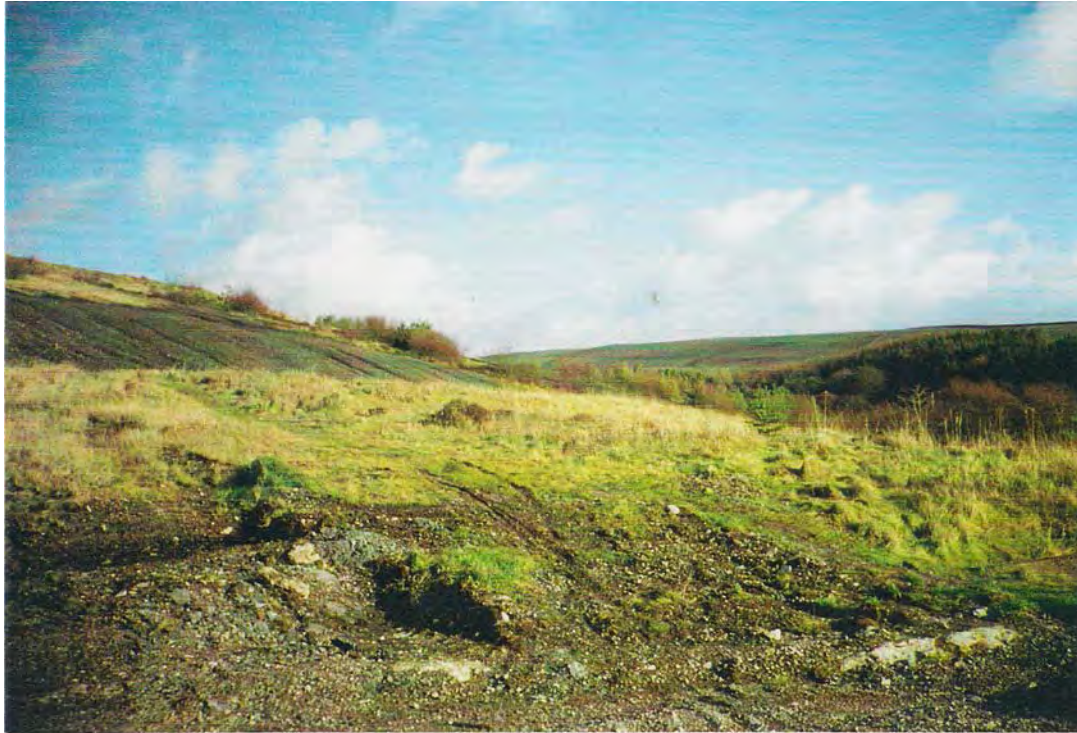
Figure 2.14: Walkmill in early 1990, before the reclamation scheme

2.5.8 The newly landscaped land at Walkmill was then covered with subsoil and grass seed was put down. It was then left for a few years to allow the grasses to develop and the soil to settle. In 1996 tree planting took place on the west side of the Walkmill site, with the east side being planted in 1998²⁴. This was the beginning of the old Walkmill Colliery becoming Walkmill Community Woodland. See figures 2.14 and 2.15 for photos of Walkmill site before and after the 1990's reclamation scheme.

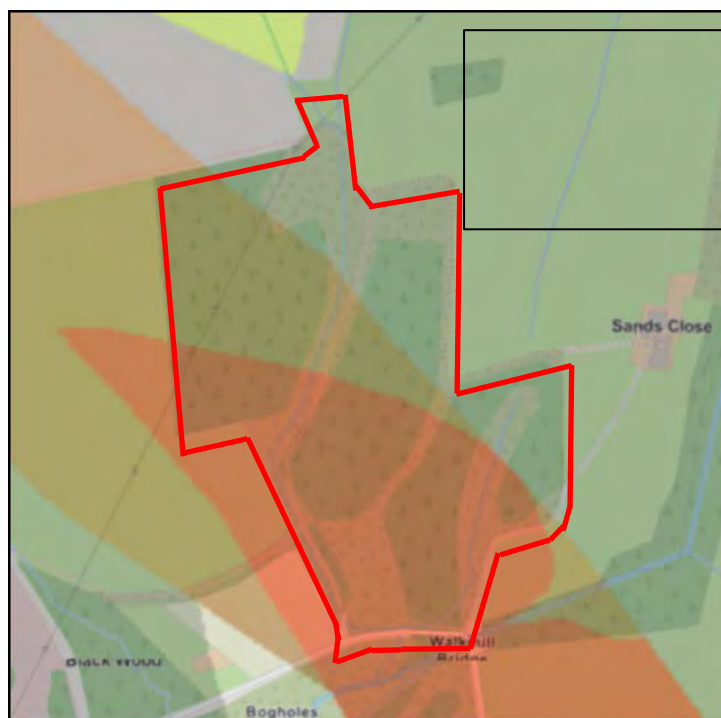
Figure 3.5 Map of bedrock geology at Walkmill Community Woodland

- Pennine Middle Coal Measures Formation - Mudstone, siltstone and sandstone. This sedimentary bedrock was formed approximately 318 to 309.5 million years ago in the Carboniferous period. It is found in the top band of the site.
- Whitehaven Sandstone Formation - Sandstone. This sedimentary bedrock was formed approximately 315.2 to 308 million years ago which was also during the Carboniferous period. This bedrock is found in the middle band of the site.
- Brockram - Breccia. This sedimentary bedrock was formed approximately 298.9 to 247.1 million years ago during the Permian and Triassic periods. It is found in the bottom band of the site.

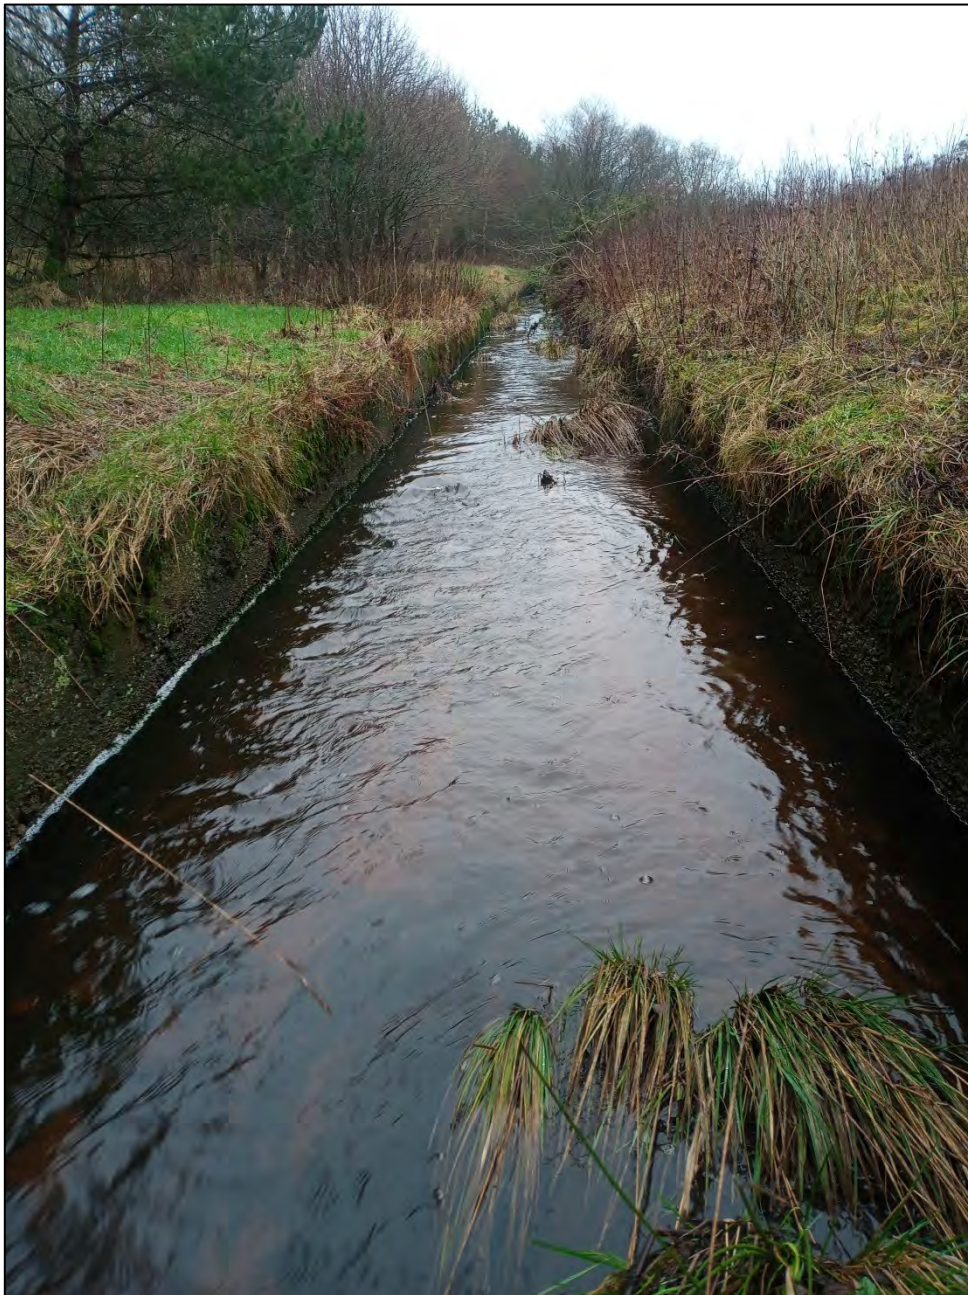
Figure 4.5 Straightened, concrete-lined beck at Walkmill Community Woodland

4.6.3 These straightened, concrete channels (see figure 4.5 below) are terrible for biodiversity as they provide no habitat for wildlife. The base of the concrete channel is bare and is unable to maintain any gravels or cobbles, which are essential habitats for in-water wildlife, such as riverfly and fish. The lack of these habitats also make the beck, in its current state, unsuitable for other wildlife too, such as dippers and grey wagtails which need suitable nesting locations along the beck and suitable boulders in the water. The concrete banks also prohibit otters or water voles being able to access the bank as they need the soft soils of a natural beck.

4.6.4 A fish survey was undertaken by WCRT in Summer 2022 and it was established that currently no fish are present in the beck. There are fish present in the River Keekle and there is suitable fish passage under the road connecting the River Keekle and the beck at Walkmill Community Woodland, however due to the poor condition of the beck with its straightened concrete channel there is currently no habitat to support fish.

4.6.6 Additionally, the channel being completely uniform leaves no room for the microhabitats that the Riverfly need to form, this was clearly shown by the minimal diversity found on site from kick sampling surveys done by WCRT and volunteers⁴¹. The Riverfly that are currently found on site are broken into two distinct ecosystems, those inhabiting the concrete channel and settling ponds and those inhabiting the stone channel. The former consists of very low scoring, high abundance (based on the WHPT⁴² scoring system) invertebrates that inhabit high nutrient stagnant pools such as those found in these channels and settling ponds. The latter contains a higher diversity of invertebrates but in low abundance. The higher diversity found here is possibly due to the heterogeneity of the stones found in this section.

4.6.7 The straightened concrete channel also means that there is a distinct lack of bends, multiple channels and connection to the floodplain, which means that water is removed far too quickly and shoots at speed down the channel. This can have numerous negative consequences including flooding downstream of the site. The excessive amount of water and speed after heavy rainfall causes all debris to be carried downstream leading to blockages in the beck (see figure 4.6 below) which in turn is causing flood damage and erosion to the footpaths at Walkmill Community Woodland. The beck has also been moved to the edge of the site and for much of the southern stretch is not accessible to visitors.

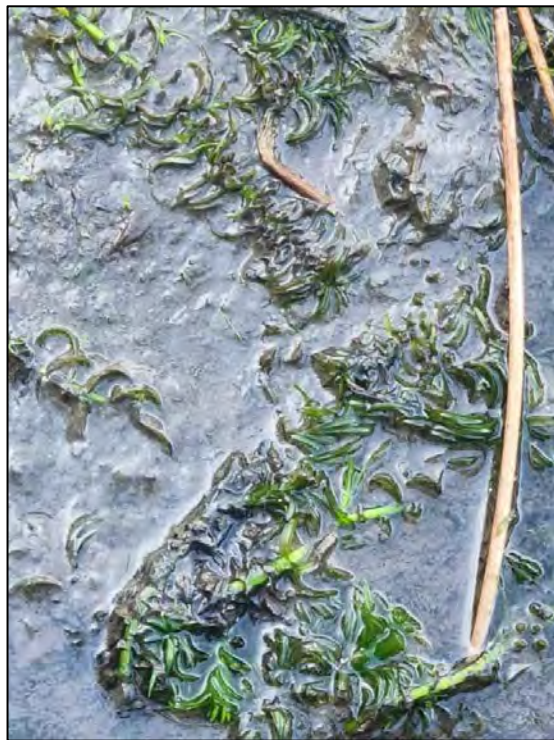
Figure 4.7 Curly Waterweed in the pond

4.7.1 In the large pond situated to the north west of the Walkmill site there is a dense infestation of curly waterweed (see figure 4.7 below) which is an invasive non-native species (INNS) that can grow in dense mats in waterbodies such as the Walkmill Community Woodland pond.

4.7.2 curly waterweed displaces native plant species through outcompeting and out-shading them as well as changing the water quality through altering the PH and silt levels. Curly waterweed is listed under Schedule 9 of the Wildlife and Countryside Act 1981 and under Schedule 14, it is an offense to let these species grow or spread. Additionally, it is listed as an Invasive Alien Species of Union Concern and is rated as having a high impact by the Water Framework Directive. Left unchecked and unmanaged curly waterweed can entirely dominate a pond, so that no other species can survive, including the diverse insect life currently present.

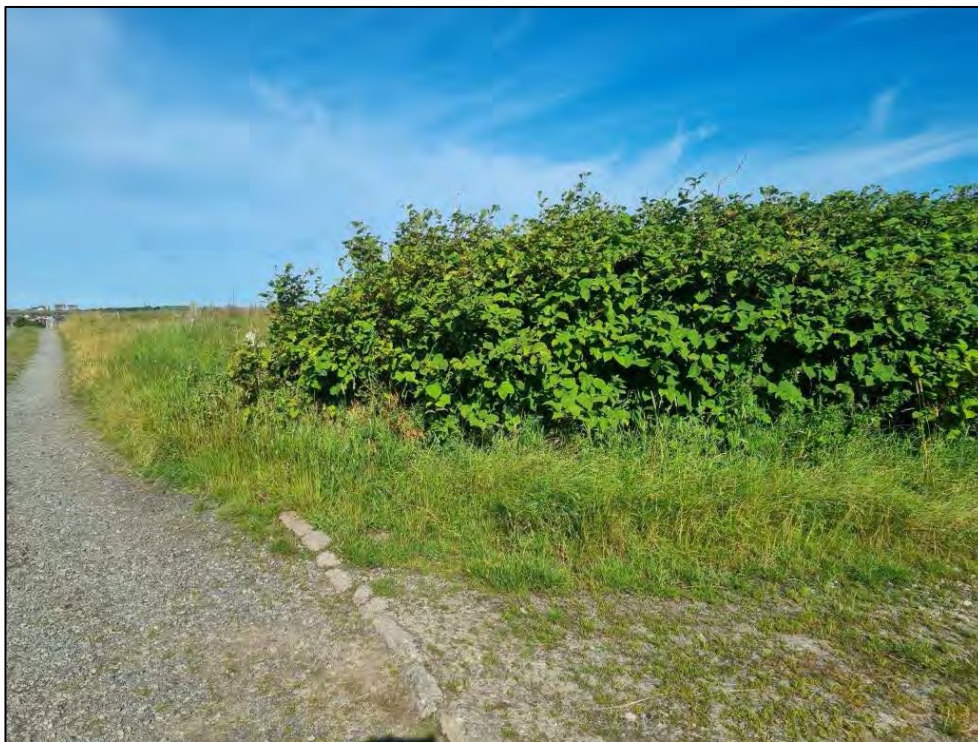
Figure 4.8 Japanese knotweed on nearby farmland

4.7.3 There is also a large stand of Japanese knotweed on nearby farmland (figure 4.8 below), measuring c. 50m² immediately north-west of the periphery of Walkmill Community Woodland. It is a perennial plant which grows each year from its extensive underground rhizomes. It spreads rapidly by natural means and as a result of human activity.

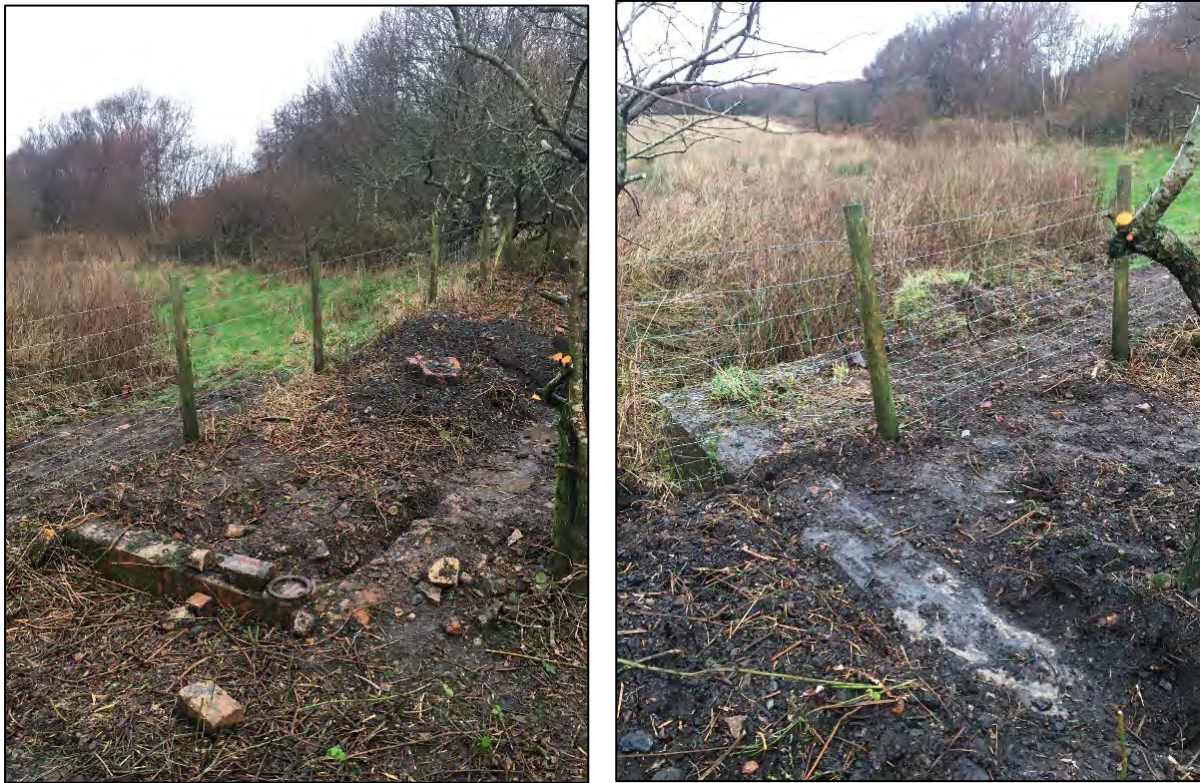
Figure 4.15: The remnants of the old weighbridge

neighbouring landowner's land. The landowner is however amenable to further uncovering of the weighbridge on his land. The remnants of the weighbridge are not in a good condition and have become very overgrown with vegetation. Some work was done to clear back this vegetation and uncover part of the remains of the weighbridge in 2022. There is, however, a risk of losing this artefact from the site's mining heritage due to erosion and dense vegetation growth.

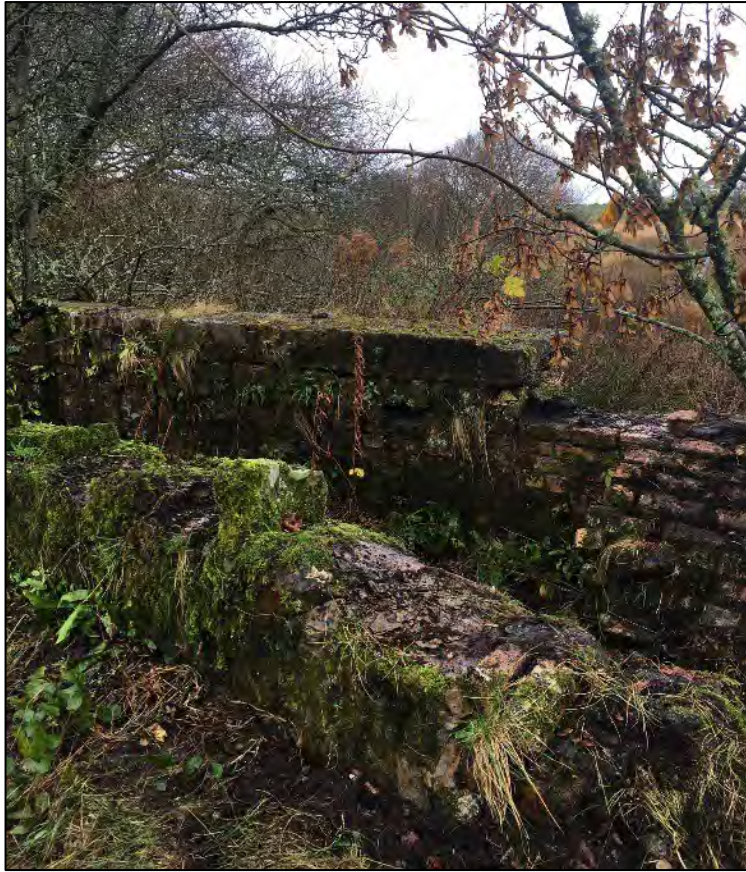
Figure 4.16: The dam to the north of Walkmill Community Woodland

4.9.3 To the north of the dam there are the remains of a large dam/weir (see figure 4.16 below). This is no longer an active dam but the brick structures have been quite well preserved. The structure is still erect and reasonably intact. There has however been some erosion and vegetation growth on and around the remains. Work was undertaken in autumn 2022 to clear some of this vegetation and to uncover the dam brick structures. This area also has an arched culvert constructed with bricks that is in reasonable condition. There are some bricks in the structure that still have the makers mark on them, 'micklam', (see figure 4.17 below) which is from the old local Micklam Brickworks which was located a few miles away in Whitehaven. These structures are however clearly suffering damage from erosion and the growth of vegetation.

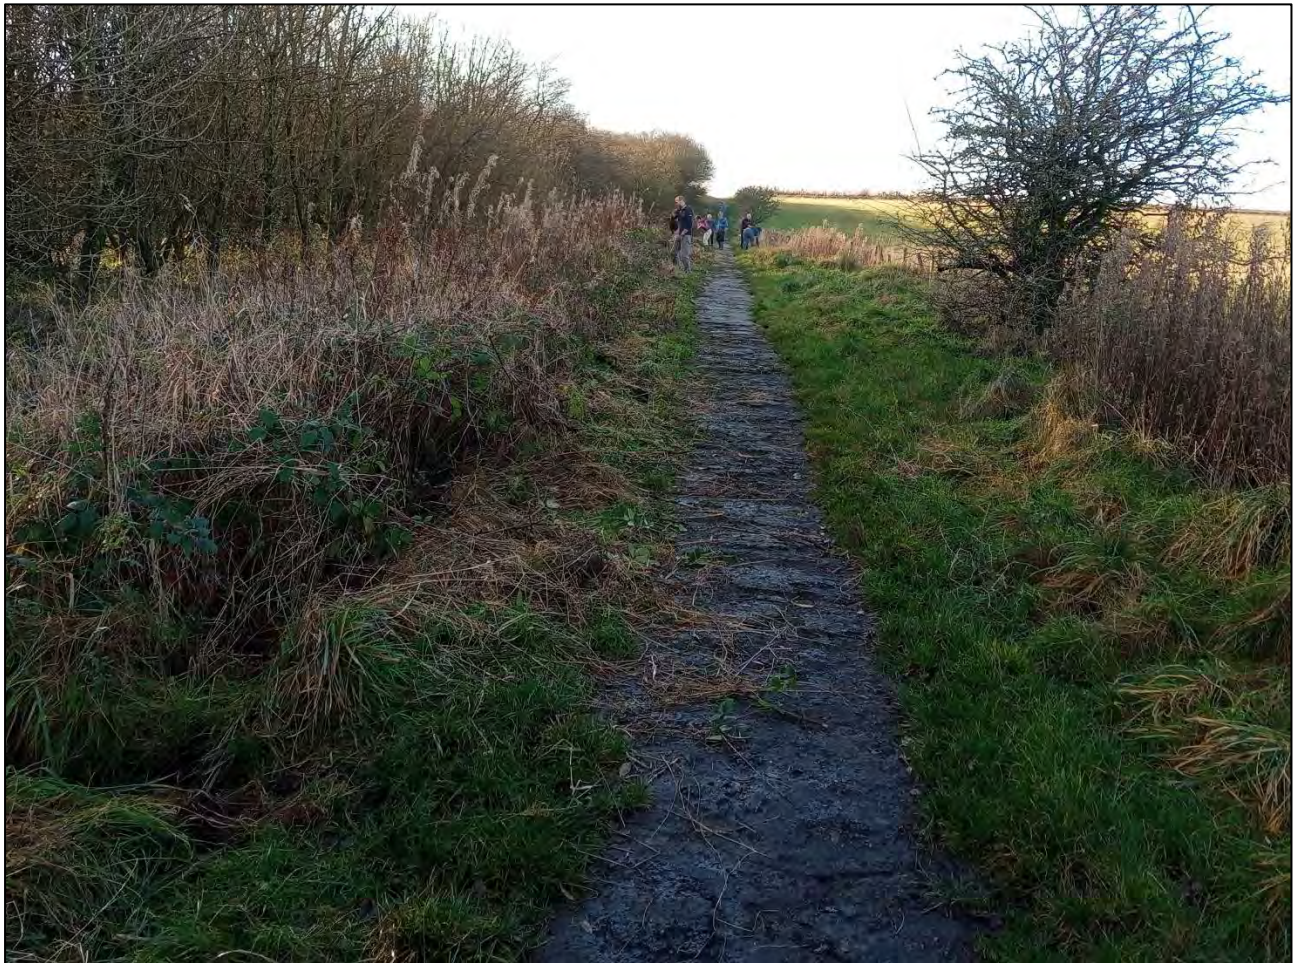
Figure 4.19: The 'Pit Road' footpath to the north of Walkmill Community Woodland

village. This footpath has a tarmac surface with grass and scrub on either side. The path has not been managed and so the tarmac is in some disrepair with some of it being cracked, broken and eroded due to water damage (see figure 4.19 below). This has lessened the accessibility of the path as it is now reported to be uncomfortable and awkward for users with wheelchairs, mobility scooters and pushchairs. This path needs replacing to make it accessible for all.

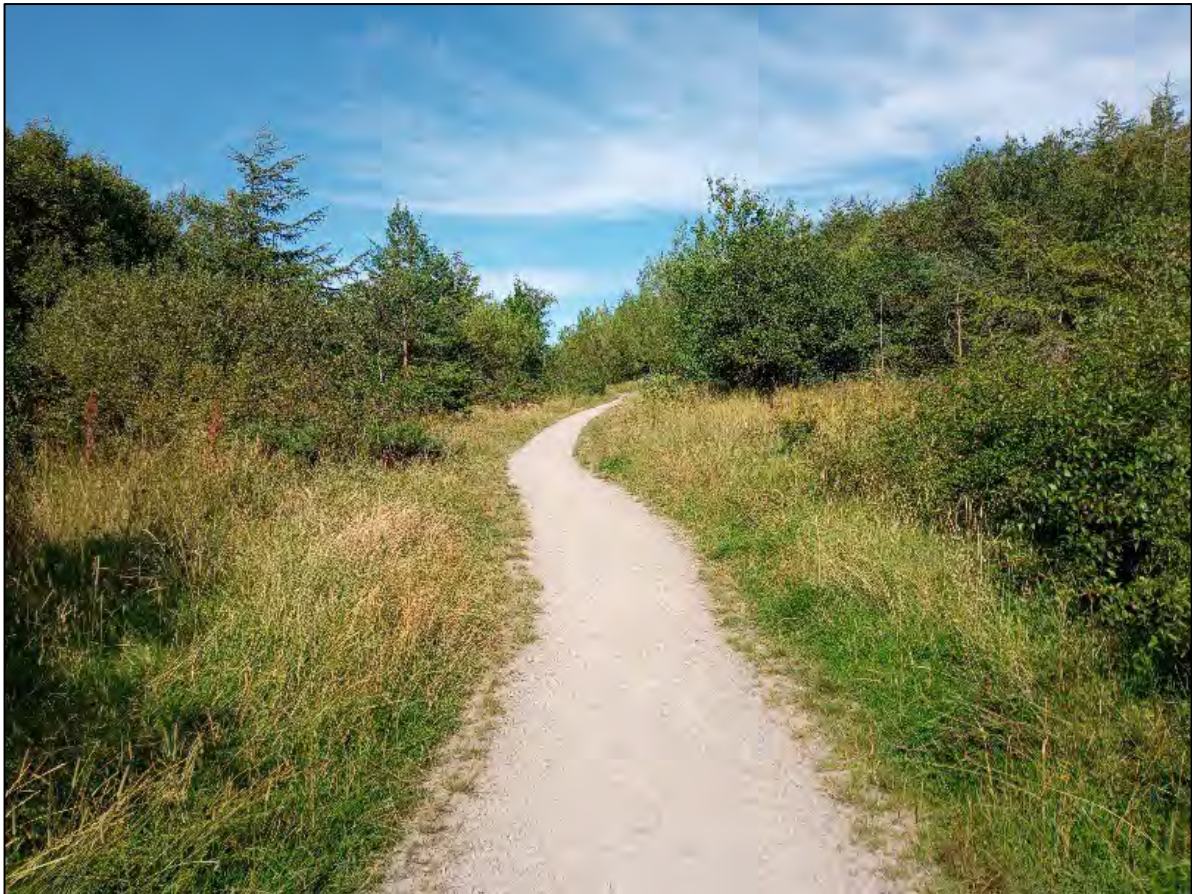
Figure 4.21: The main aggregate public footpath through Walkmill Community Woodland

4.10.4 The main public footpath through the site is an accessible aggregate path, which is currently the most used path (see figure 4.21 below). It is in a good condition with a level, undamaged surface and drainage ditches and pipes alongside it to help prevent flooding and erosion of the path. These drainage ditches are in a reasonable condition but they do require yearly maintenance and the path is currently flooding in one section during the winter months.

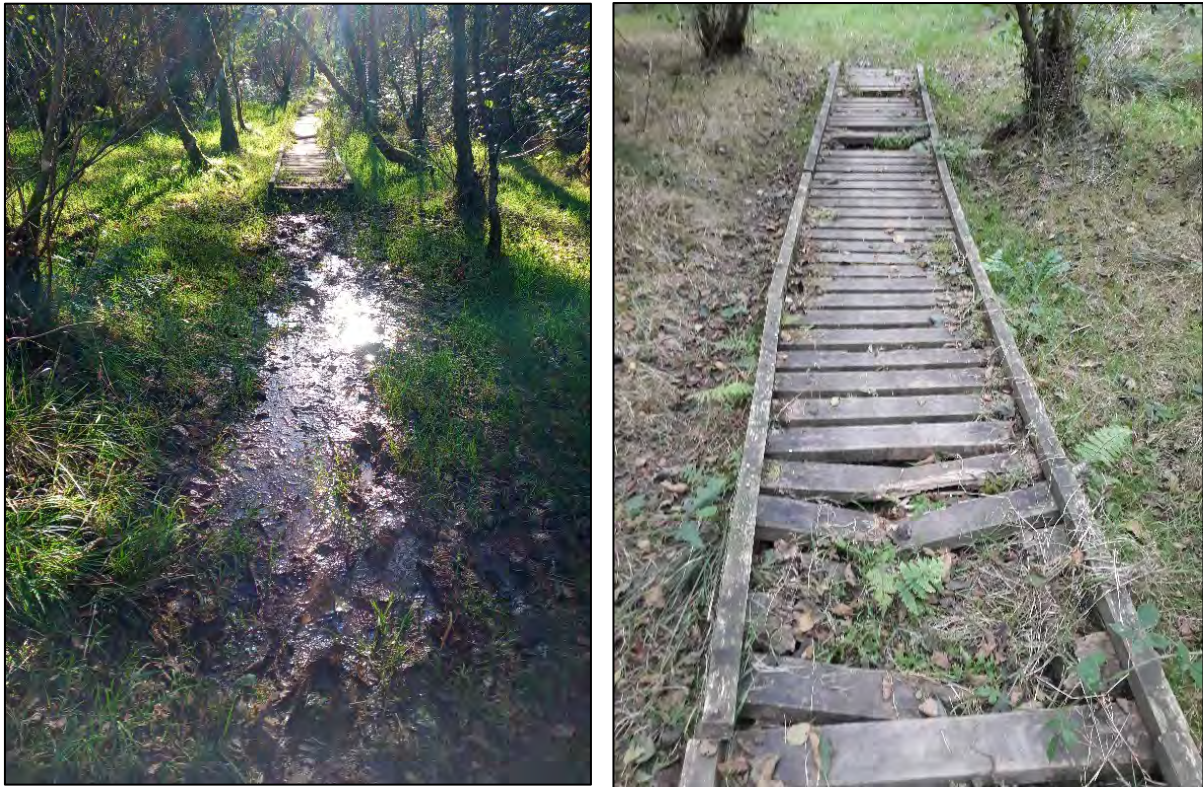
Figure 4.23: Damaged boardwalk and wet, boggy footpath

begun to walk next to the boardwalks instead. The ground to the side of the boardwalks and in between them gets very wet, boggy and waterlogged - see figure 4.23 below.

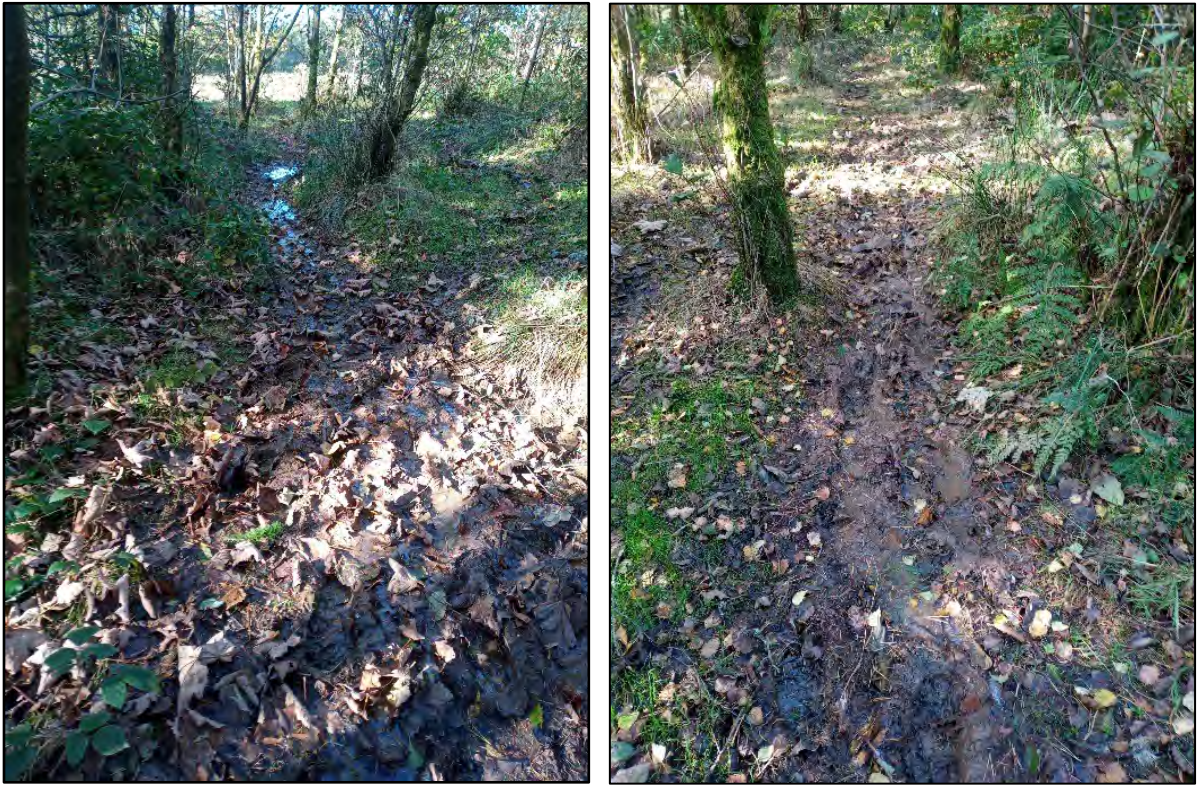
Figure 4.24: Wet and boggy path through woodland

4.10.10 The informal path that links the two valleys through the woodland is another grass path with no surfacing. The path stays continually wet and boggy and verges on impassable even in wellies in the winter months (see figure 4.24 below). The woodland it wanders through has not been managed and so has a very dense canopy with scrub encroaching on the path. This path is in a poor condition and is only accessible to some people for the summer months.

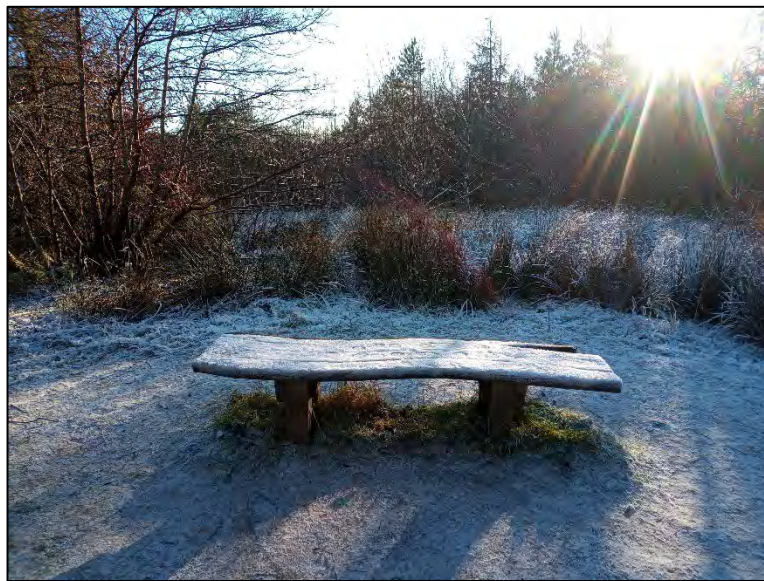
Figure 4.25: Viewpoint bench

4.11.3 There are numerous benches at Walkmill Community Woodland. The accessible picnic bench and park bench at the viewpoint were all put in by Cumbria County Council in the reclamation phase of the site. Two benches were also donated by WCRT in 2020 and are made out of the plastic liner taken out of the River Keekle. The remaining benches are simple park benches constructed by a volunteer in 2022 using fence posts from the fence removal and donated scaffolding boards and all have names relevant to the site (see figure 4.26 below) . All the benches are in a reasonable to good condition and are well used by the general public.
