Habitat Characterisation Survey

Electrofishing Results
Summer 2015

West Cumbria Rivers Trust

Summer 2015

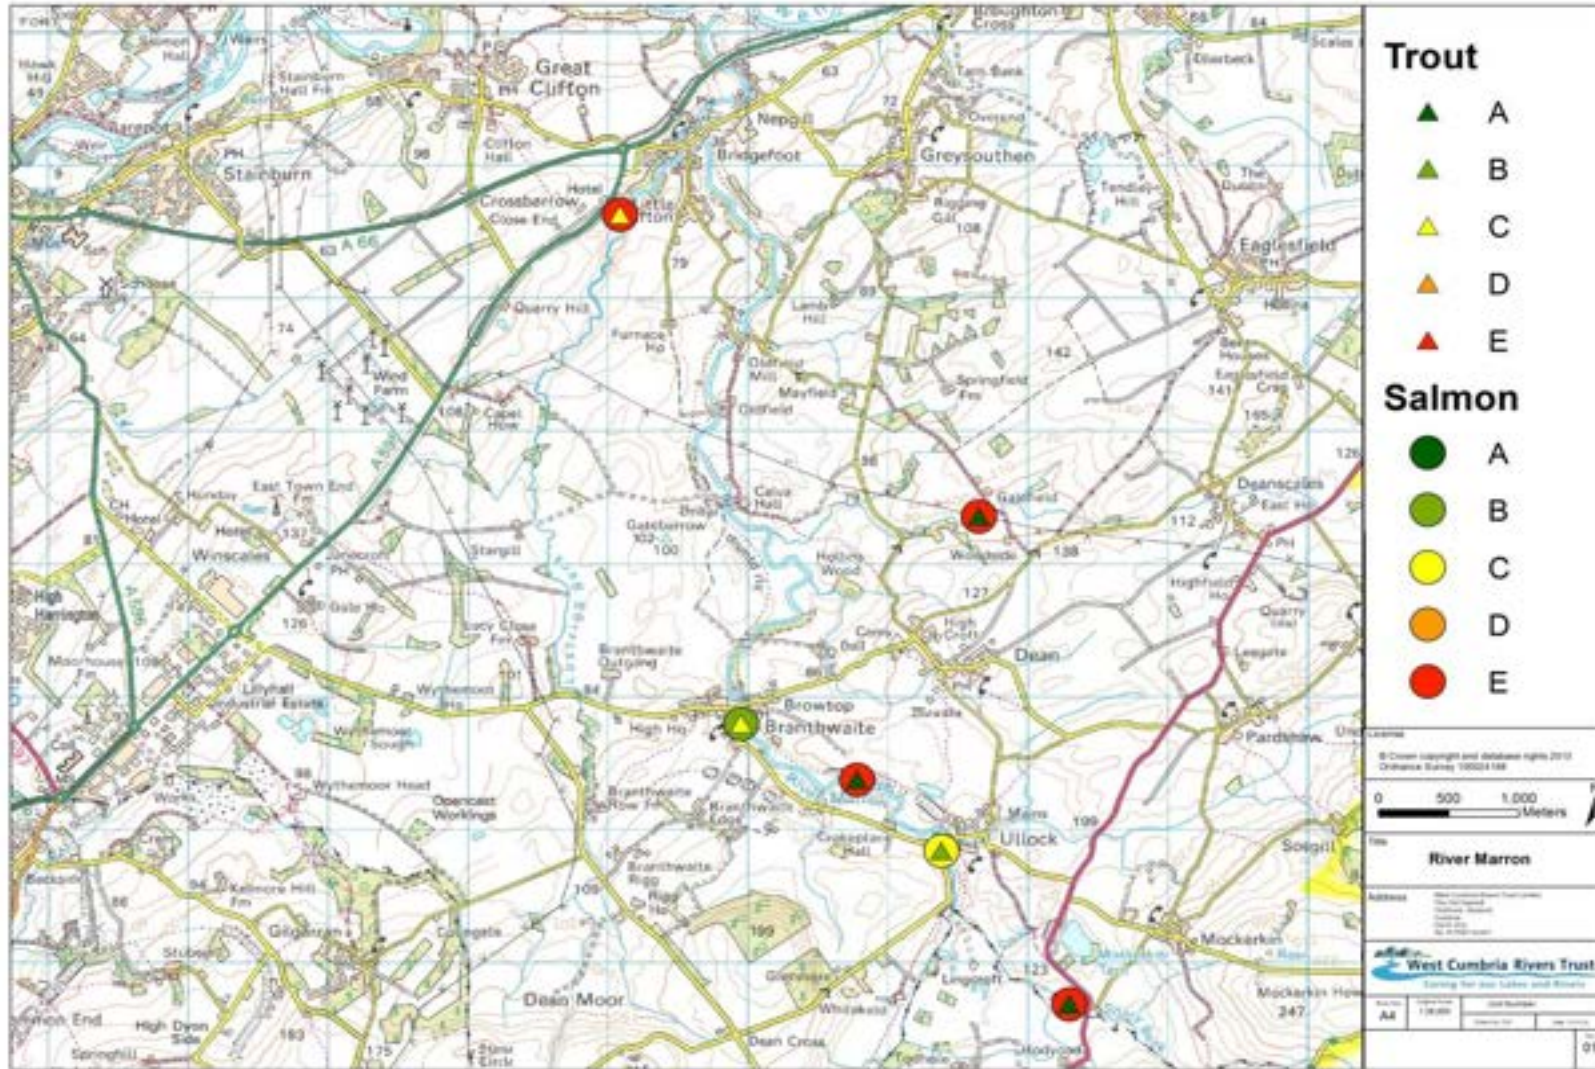
Figure 2: River Marron

- Figure 1 - catchment wide map showing salmonid fry occurrence and proportions for each species (or absence where neither species was found) at each site.
- Figures 2 - 11; individual tributary maps showing trout and salmon fry at each of our sites grouped (separately for each species) into occurrence categories A - E for each species.
