# Derwent Catchment Characterisation Survey

Electrofishing Report,  
Summer 2017

Project	Report No.	Revision No.	Date of Issue
Derwent Catchment Characterisation Survey 2017	003	001	February 2018

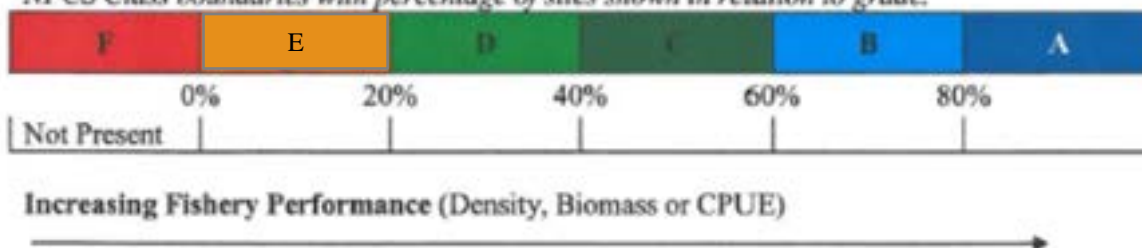
**Figure 1:** NFCS grades from A (the top 20% of fisheries performance in England and Wales) to E (the bottom 20% of fisheries performance in England and Wales), with F as no fish present

- 2.1.7 Data analysis consisted of statistically assigning the recorded fish densities to the national fisheries classification scheme (NFCS) using the calibration results, so that the data could be compared year on year, and also with data from across the country and collected using different survey methods. (Please note that a direct comparison of sites is not statistically robust as fish densities are extremely variable in space and time, and multiple years' worth of data are required to build up a picture of trends in fish density) The NFCS has classifications ranging from A to F as shown in Figure 1.

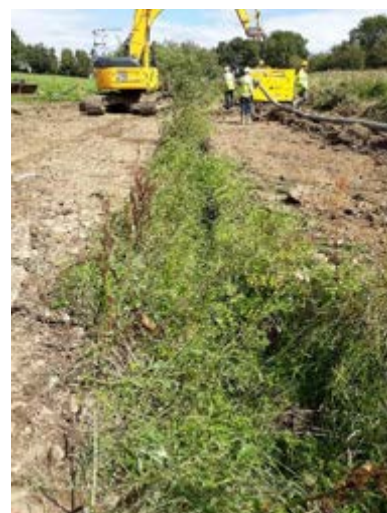
*Figure 4: Photo of an unnamed tributary of Brides Beck where a fish rescue took place and no fish were found.*

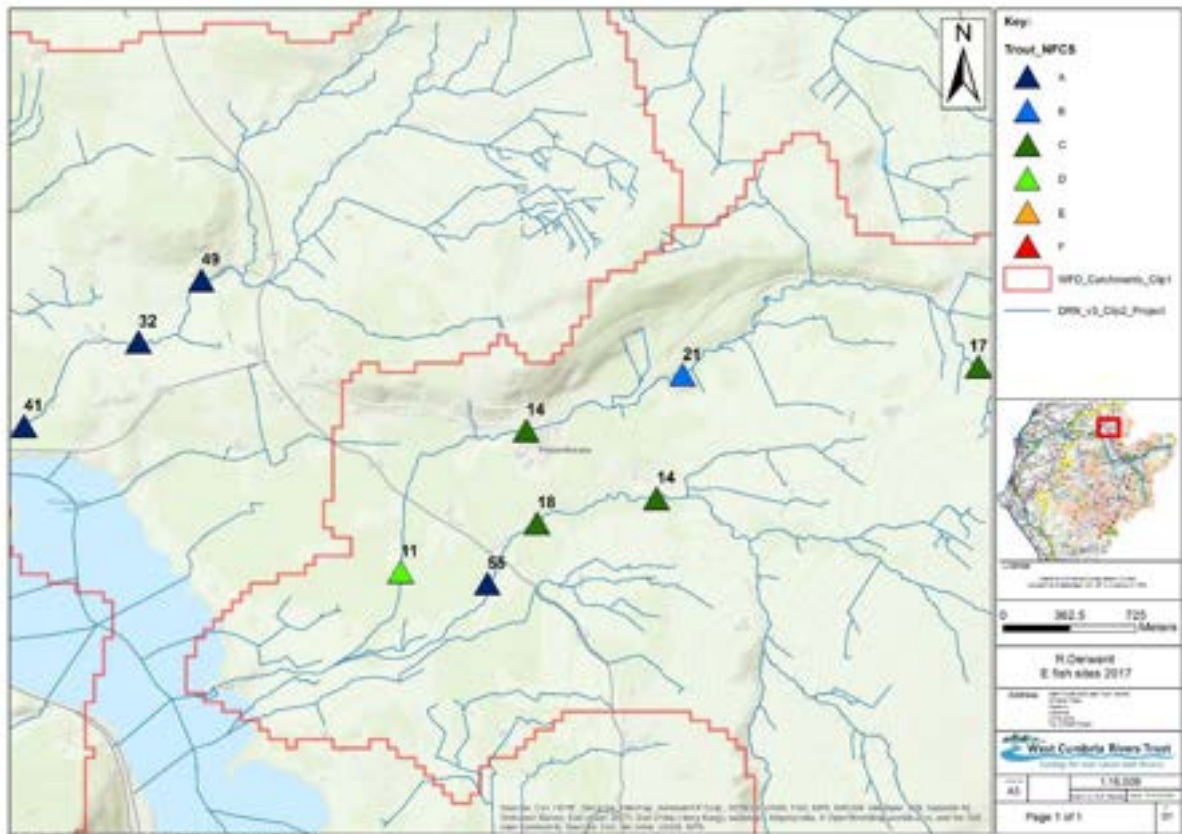
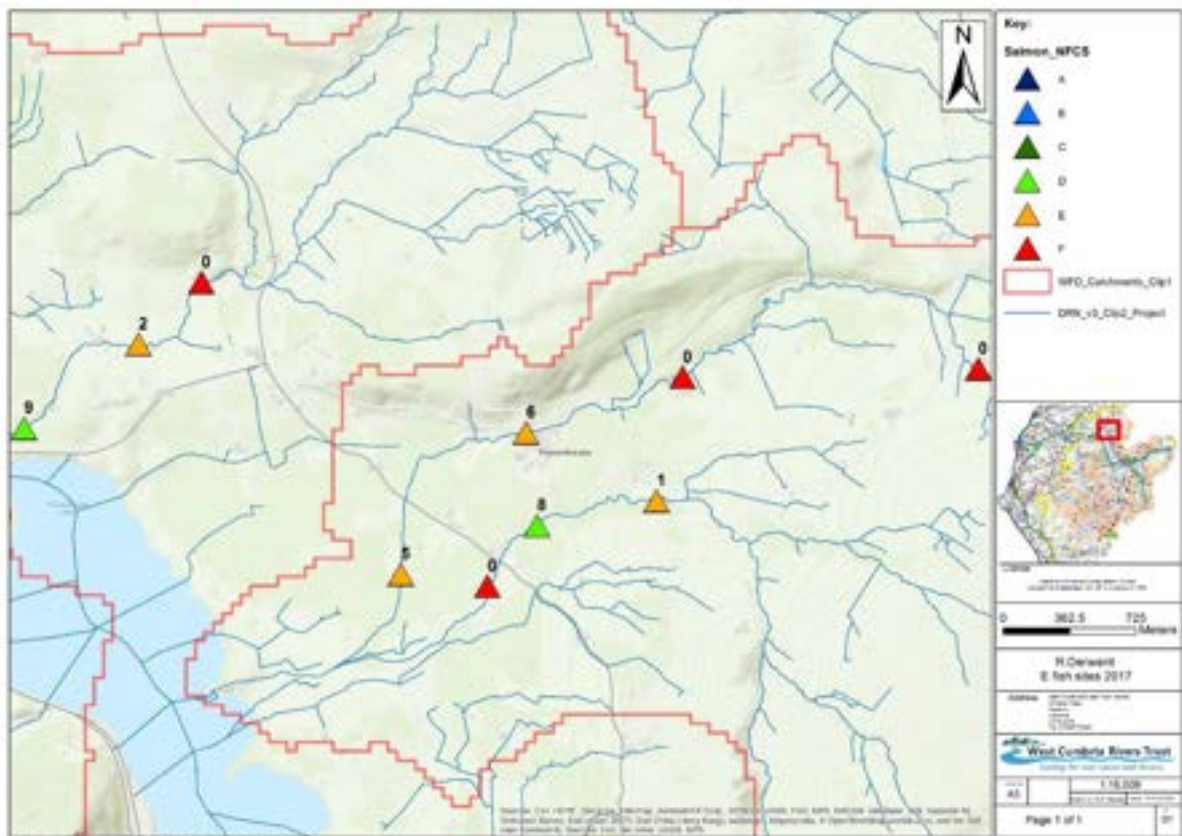
**Figure 13:** 2017 NFCS Classification and fish numbers for Wythop Beck. Top image Trout, bottom Salmon.

- 3.2.4 Figure 5 and Figure 6 shows the NFCS results for just the 2017 survey for Trout and Salmon respectively.
- 3.2.5 Figures 7 to 27 show the NFCS results for both Trout and Salmon broken down by tributary area for more clarity.

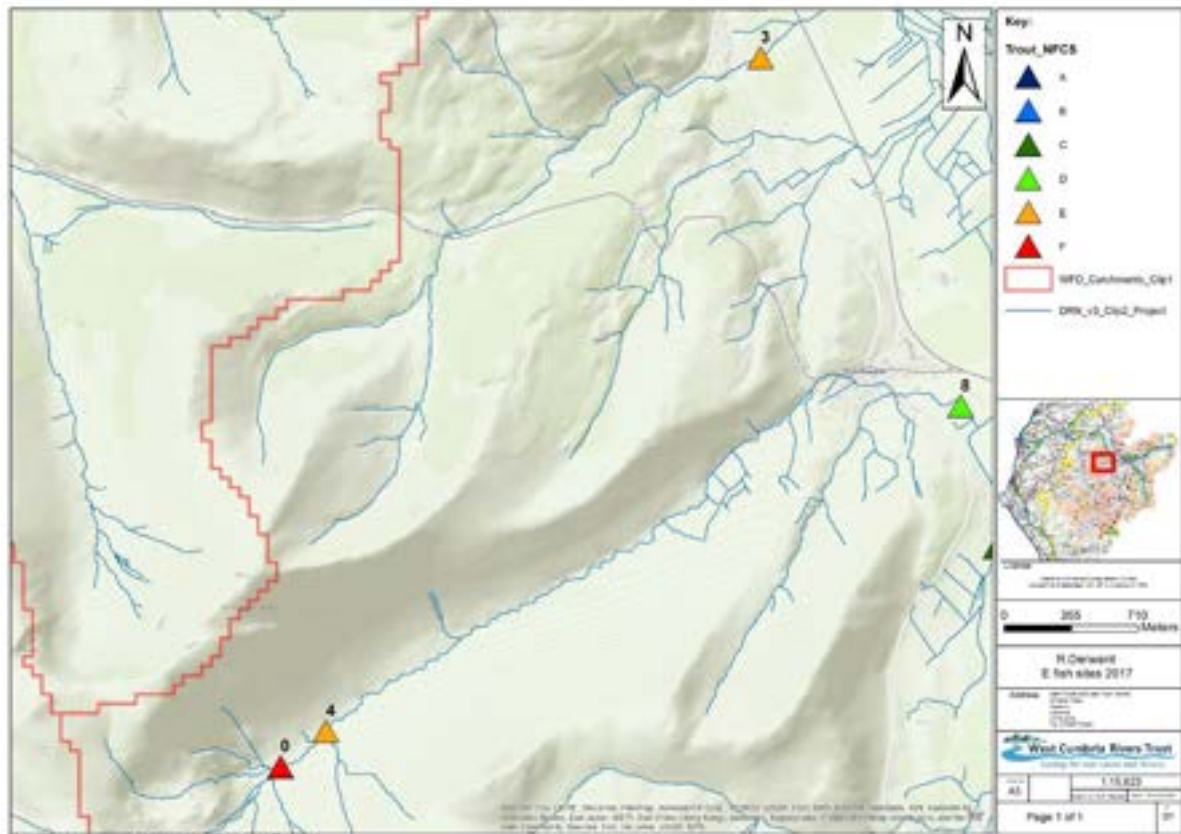
Figure 16: 2017 NFCS Classification and fish numbers for Glenderamackin (includes: Barrow Beck). Top image Trout, bottom Salmon.

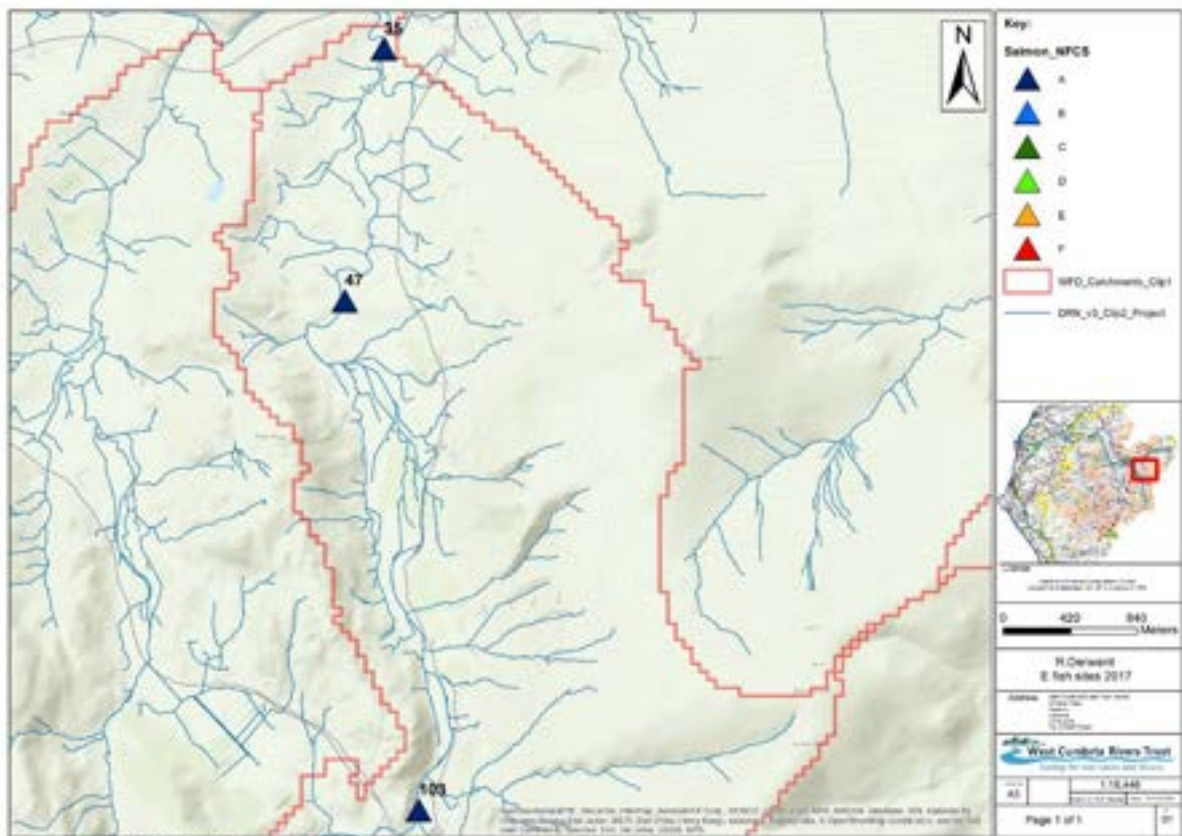
**Figure 25:** 2017 NFCS Classification and fish numbers for Mosedale (includes: Glenderamackin). Top image Trout, bottom Salmon.

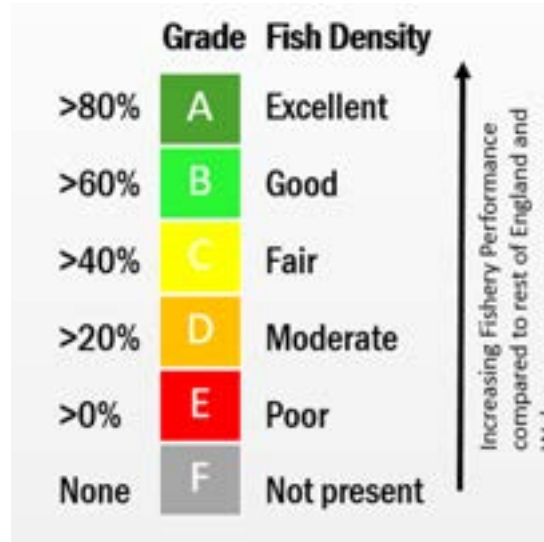
*Figure 28: National Fisheries Classification Scheme colour scheme used in 2016 and 2015 reports.*

The project has had a couple of different project officers and the previous officer used a different colour scheme to the one used in this report, so for the comparison section, the colour scheme has been changed to the one in Figure 28 to make the comparison between the years easier.

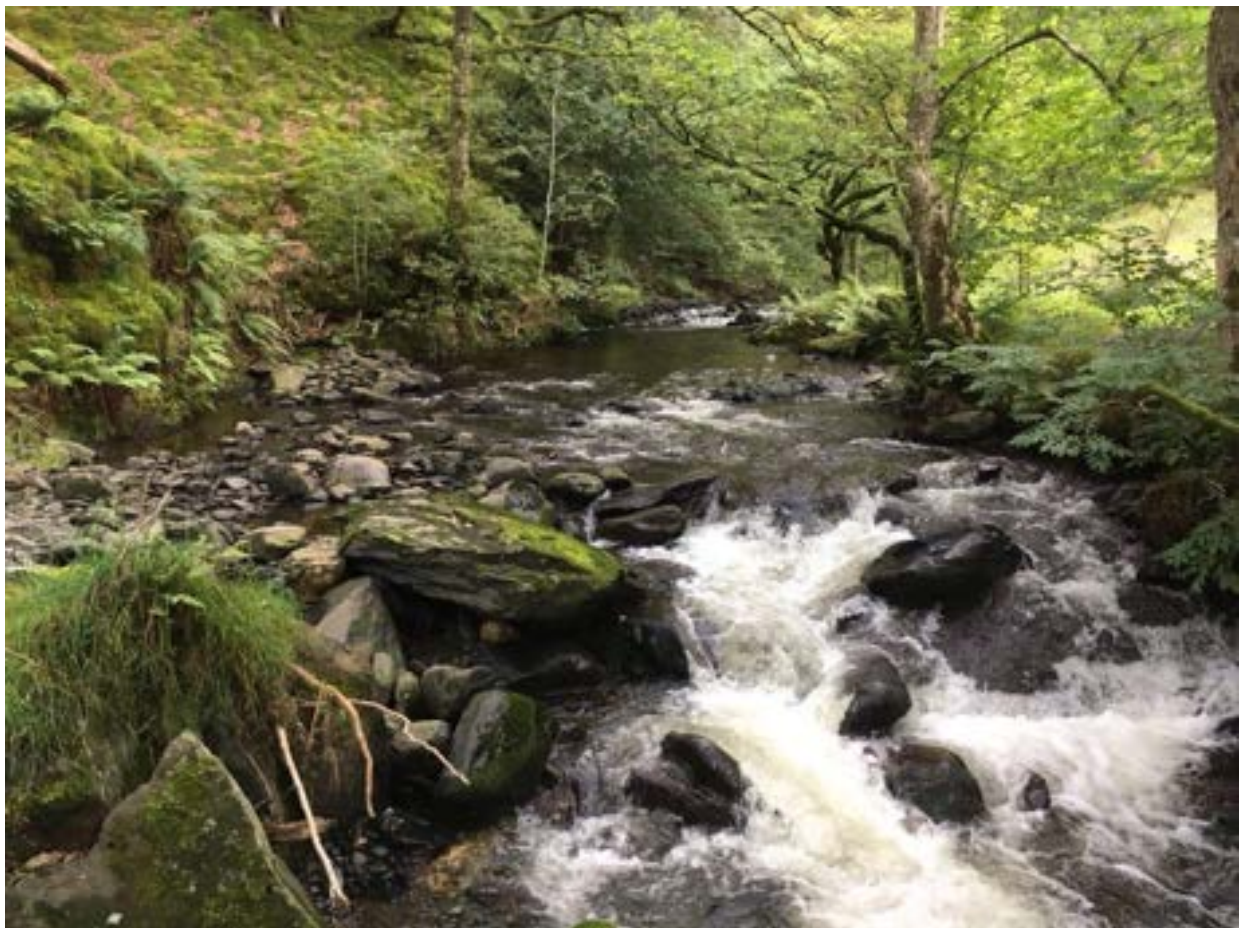
*Figure 32: An example of a survey site classified as Maintain, with dappled shade, gravel provision, minimal silt and no stock access.*

- **Maintain** - limited small scale work required such as insertion of large woody debris or tree maintenance (for example, Figure 32).
- **Repair** - modest work such as fencing off buffer strips, provision of new gravels, willow spiling, invasive species control and tree planting (for example, Figure 33).
- **Restore** - major restoration works such as re-routing the channel required (for example, Figure 34).

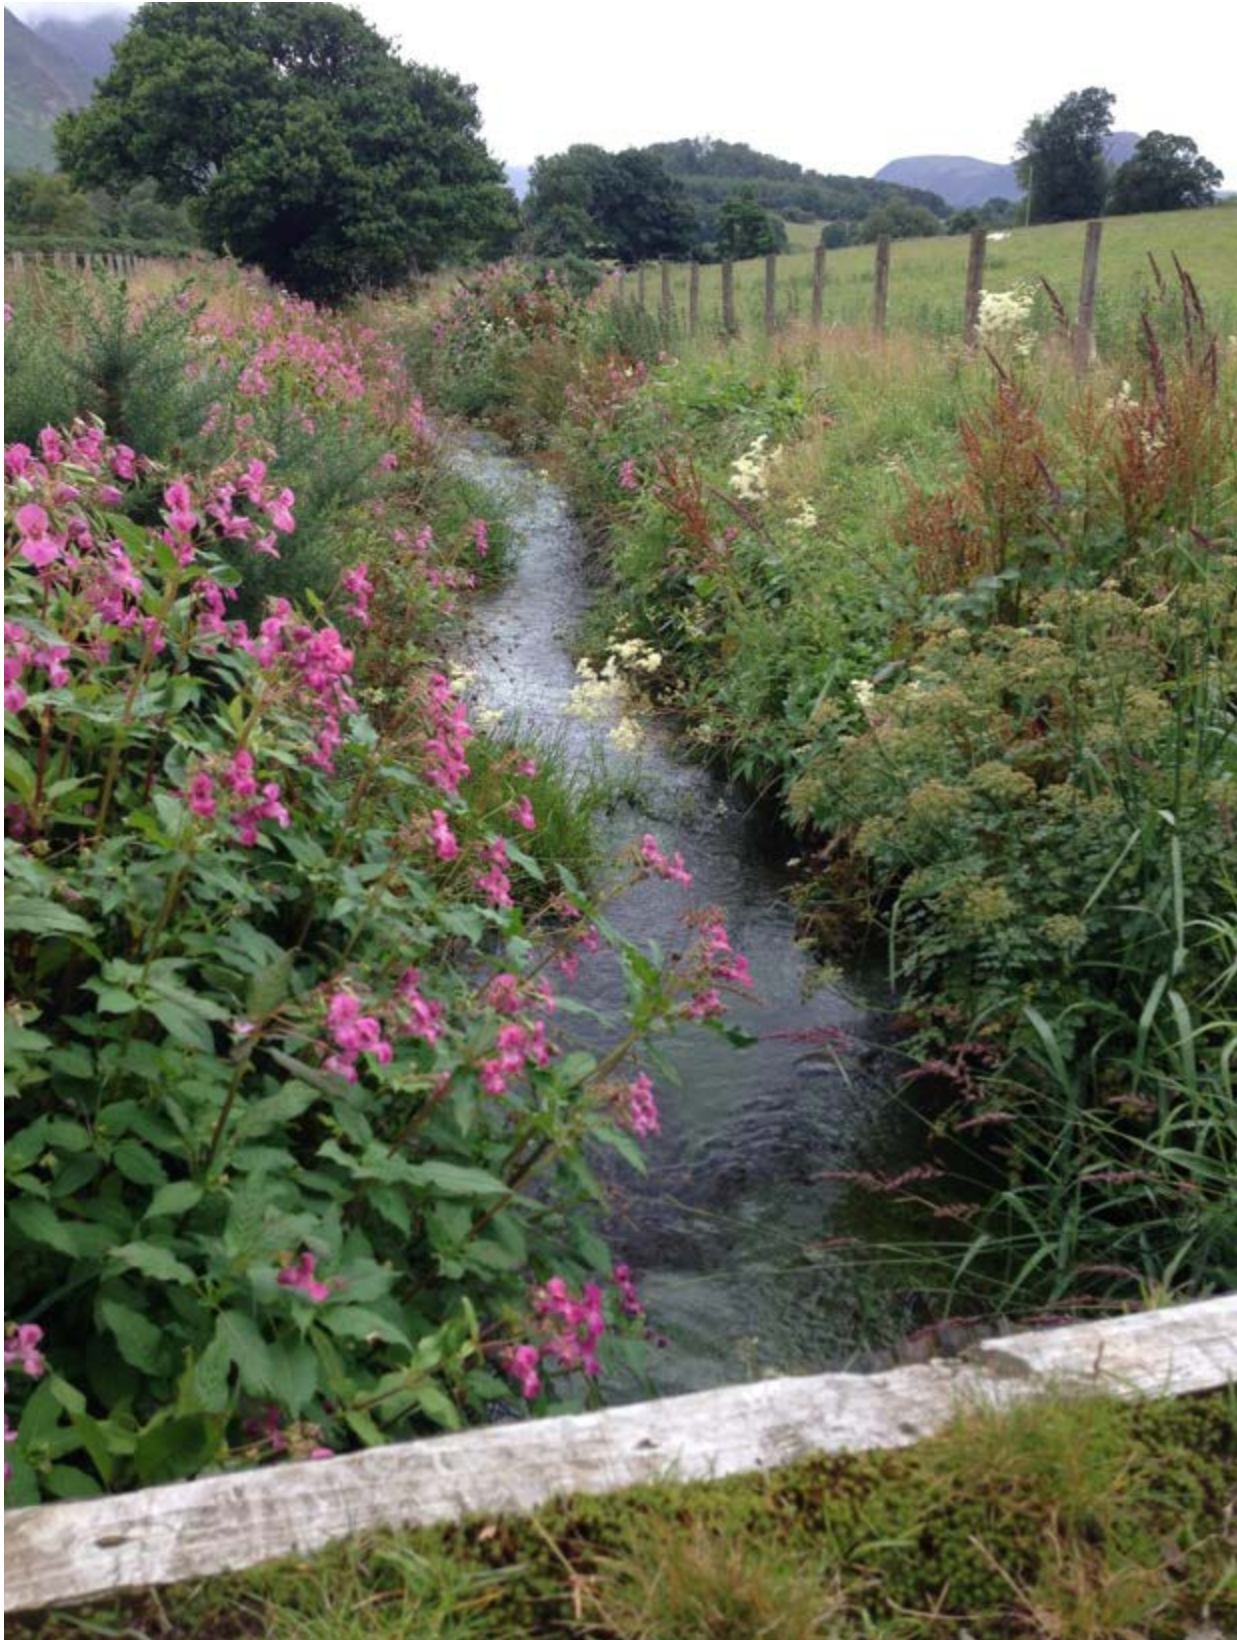
*Figure 33: An example of a survey site classified as Repair, which even though it is fenced and has a reasonable buffer strip and good substrate - lots of cobbles and gravel, there is loads of Himalayan Balsam, no trees or woody debris to create dappled shade or places for fish to hide.*

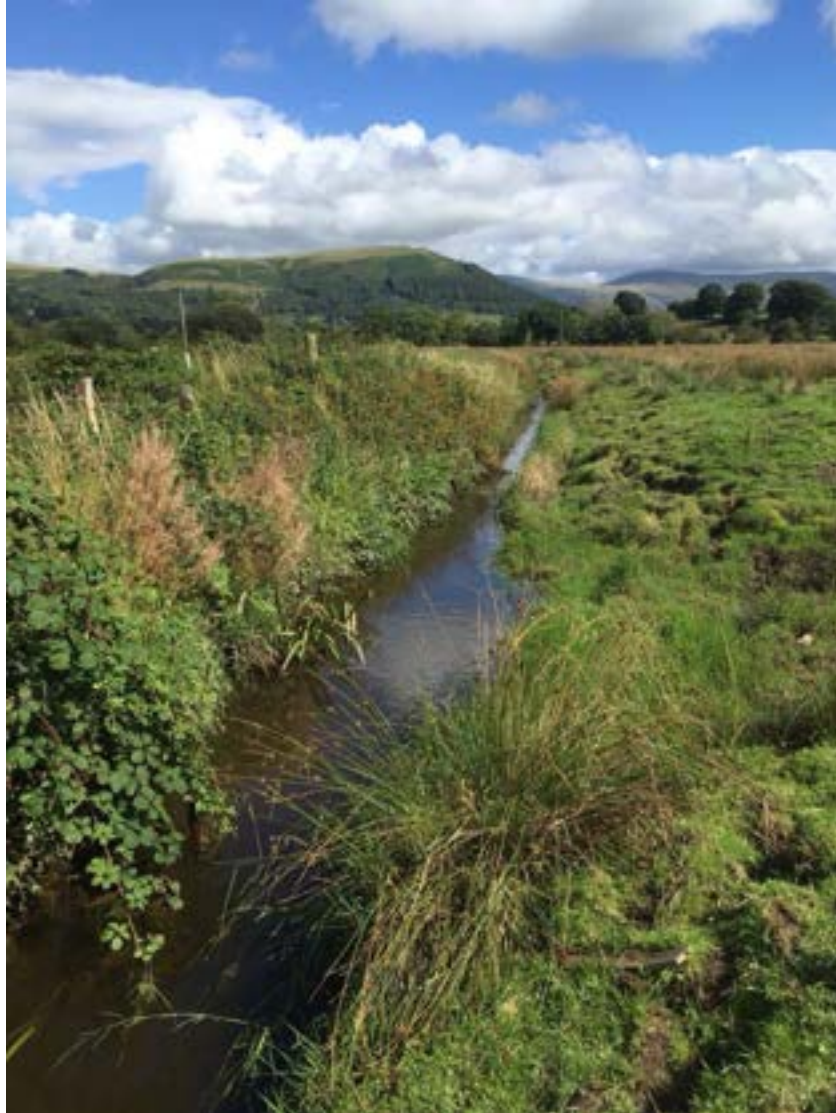
**Figure 34:** An example of a survey site classified as *Restore*, which has a major siltation problem, no shade from trees and minimal riparian fencing, livestock have access on the right and are damaging the banks.
